3243

Damage to brick-lined culvert during flood

England

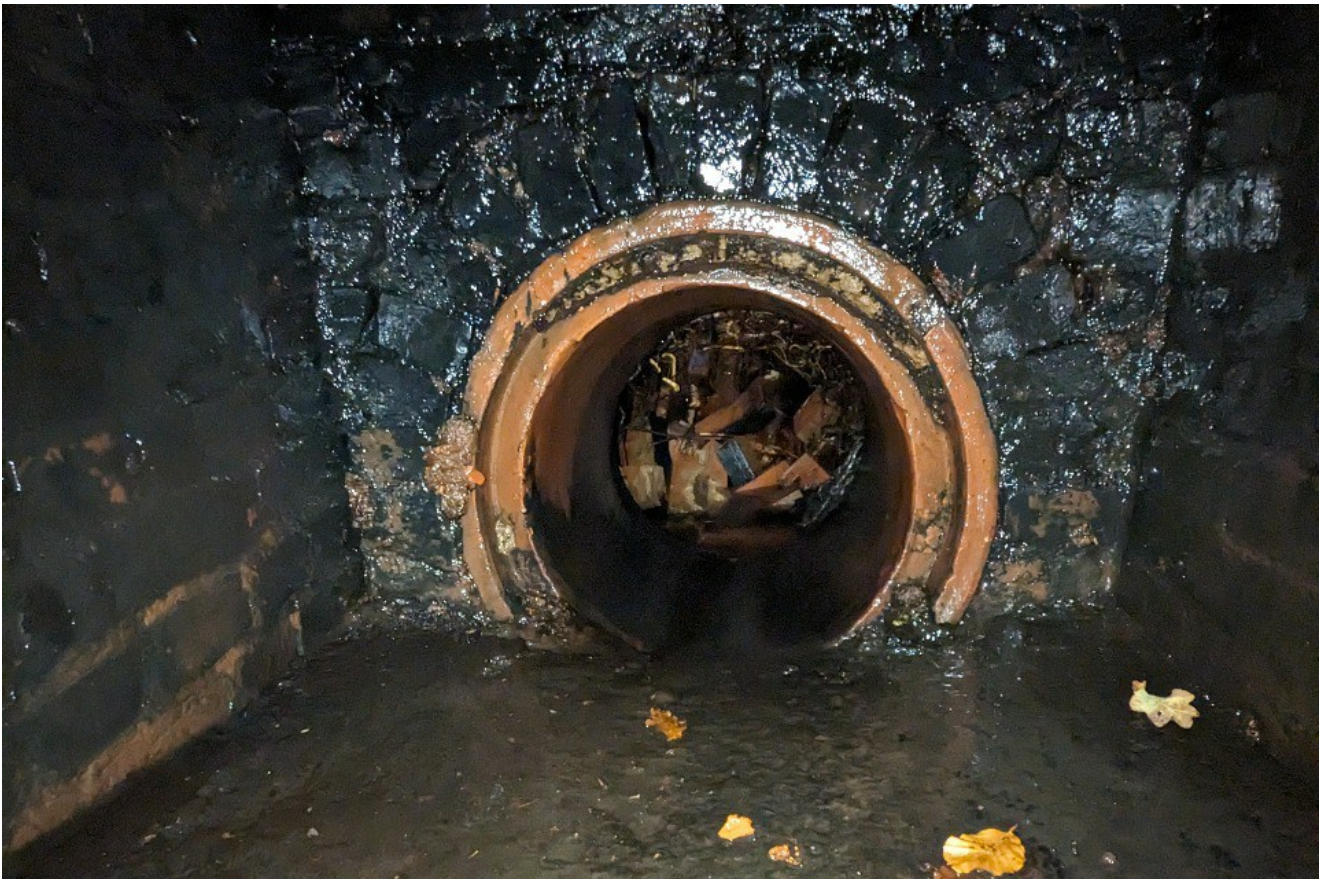
During the passage of a flood event, damage was caused to a 450mm diameter brick-lined spillway culvert under an earthfill dam embankment. A sinkhole was discovered on the line of the culvert just downstream of the downstream toe of the embankment. The available drawoff facilities are connected into this common outlet culvert that had become blocked therefore, these outlets could not be used to lower the reservoir water level. A pump was deployed to reduce the reservoir water level and the flow passing through the culvert. Fortunately, the dam did not overtop as a result of the incident. Visual inspection from a chamber immediately downstream of the damaged section of culvert found that the brick lining of the culvert had completely collapsed. Excavation revealed the presence of tree roots within the culvert. On clearing the blockage, tree roots were observed to be present in many locations through the crown of the culvert. As a temporary repair, a section of pipe was installed to act as a sleeve past the area of damage until a permanent repair or replacement pipeline can be provided.
