3253

Erosion from overflowing of flood storage reservoir on embankment not designed to spill

514

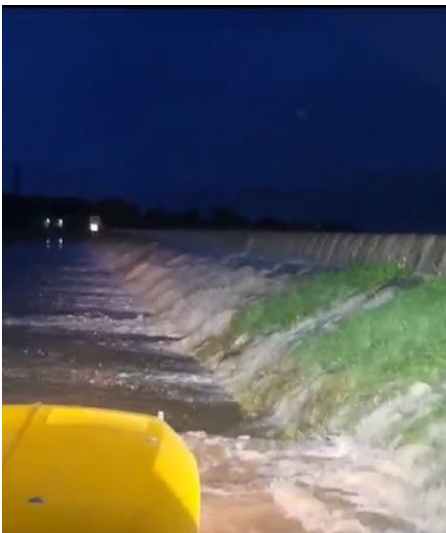
During Storm Babet, a river next to the dam overflowed the dam and caused erosion to the dry side of the bank. The embankment topsoil eroded down to the core material in various locations along the 600m length. The core is homogeneous and of good cohesive material, preventing further deterioration. The reservoir is an offline reservoir used to receive the tributary flow from a nearby beck. In an extreme flood event on the river, the reservoir can fill by overtopping the piled river defence. It acts as an unintended but high-level spill point. The piled river defences retain the upper 600mm of flood defence level. The piles are beyond their original design life and their length is thought to be around 5m long. The riverside exposed pile length is greater than the landward side by 2m. If the fill material was eroded away from the reservoir side, the piles would likely fail. Therefore, the embankment profile must be maintained to act as designed in a composite manner. This overtopping previously occurred in 2007. It caused minor scour at the piles interface with the embankment then. The undertakers constructed a splash pad post-2007 to alleviate the issue occurring again. In this incident, broad leaf plants such as docks and thistles worsened the erosion. Thistles and other stalks can cause micro-turbulence, exacerbating the erosive forces. The undertaker completed immediate temporary repairs once the flood flow had receded. During the incident, the local authority emergency response team closed a road to enable the emergency works. A QCE and the supervising engineer provided recommendations for short-, medium- and long-term repairs. The undertaker is looking to action these recommendations.

Post flood actions were undertaken to carry out emergency temporary repairs to the embankment. The SE, also a QCE, was liaised with to ensure the temporary works design was appropriate should another flood event cause further overtopping. The On Site Plan was effectively put into action and appropriate personnel and resources deployed to action a recovery plan. The recovery plan involved liaison with professional partners to enable emergency road closures to undertake the temporary repair works. The main materials used were sandbags and bentonite geotextile fabric to act as robust erosion protection to the areas of scour.

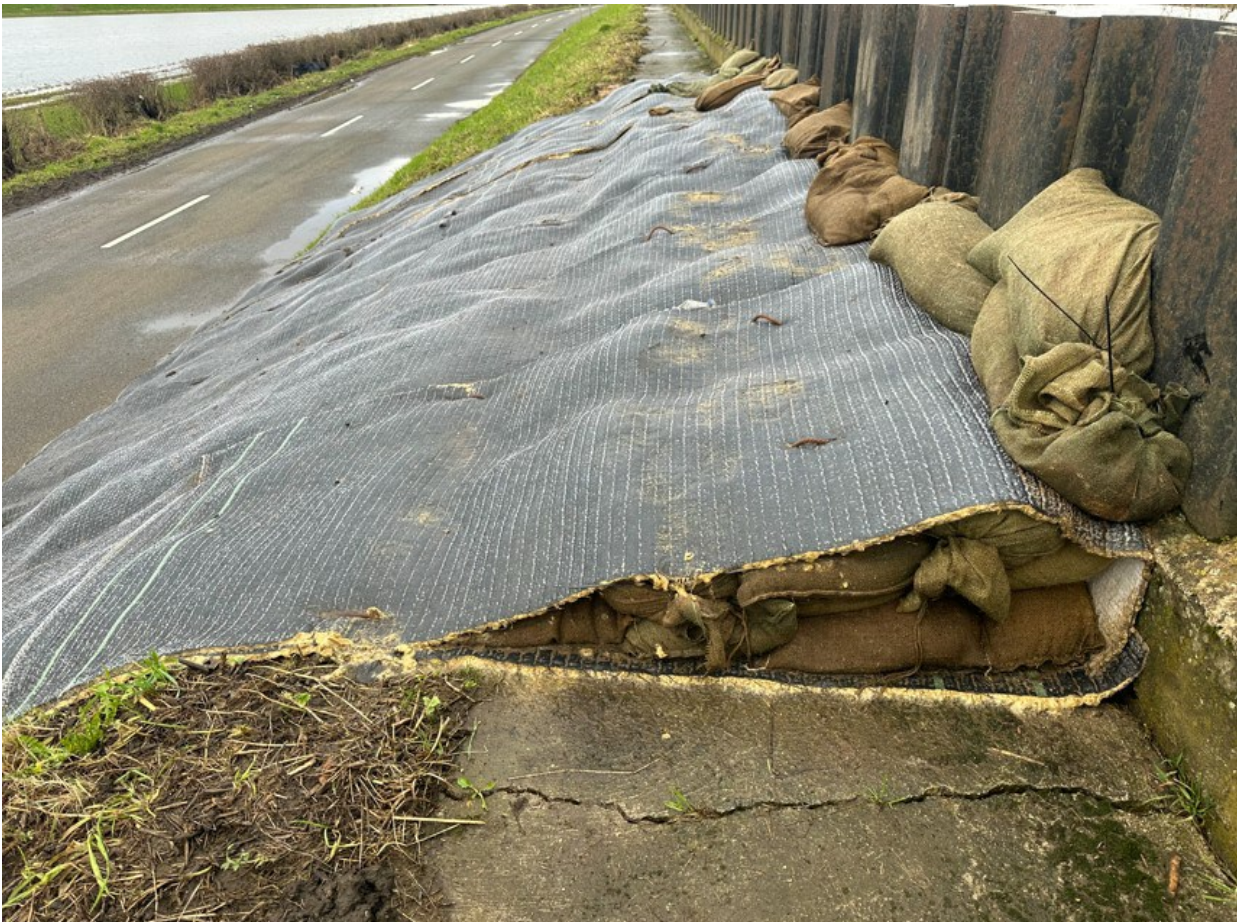
- Deterioration of materials

- Excessive or damaging vegetation (not trees)

- Design shortcoming
- Maintenance shortcoming

- External erosion
