3261

Leakage from small raised reservoir

09 December 2024 - 12:00

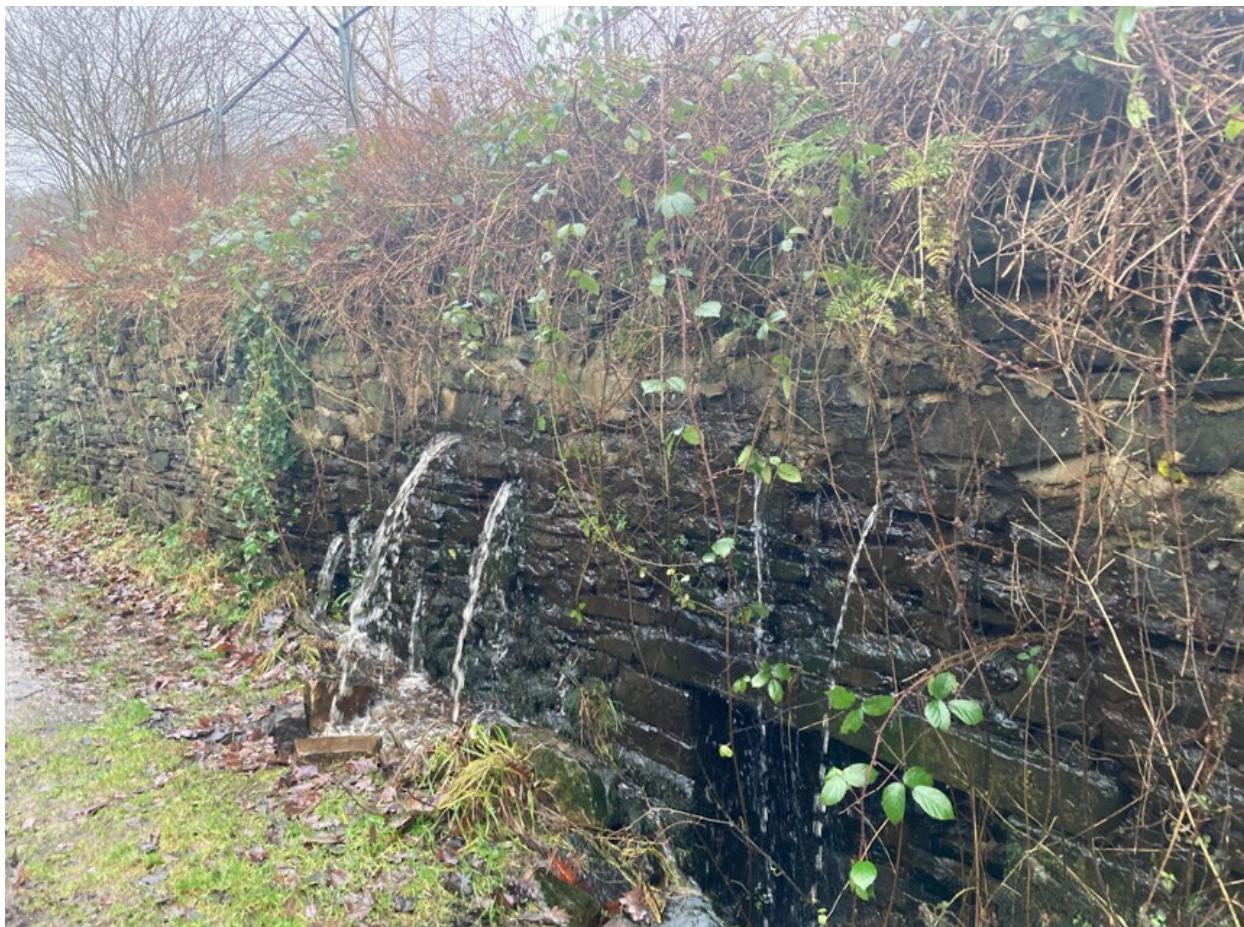
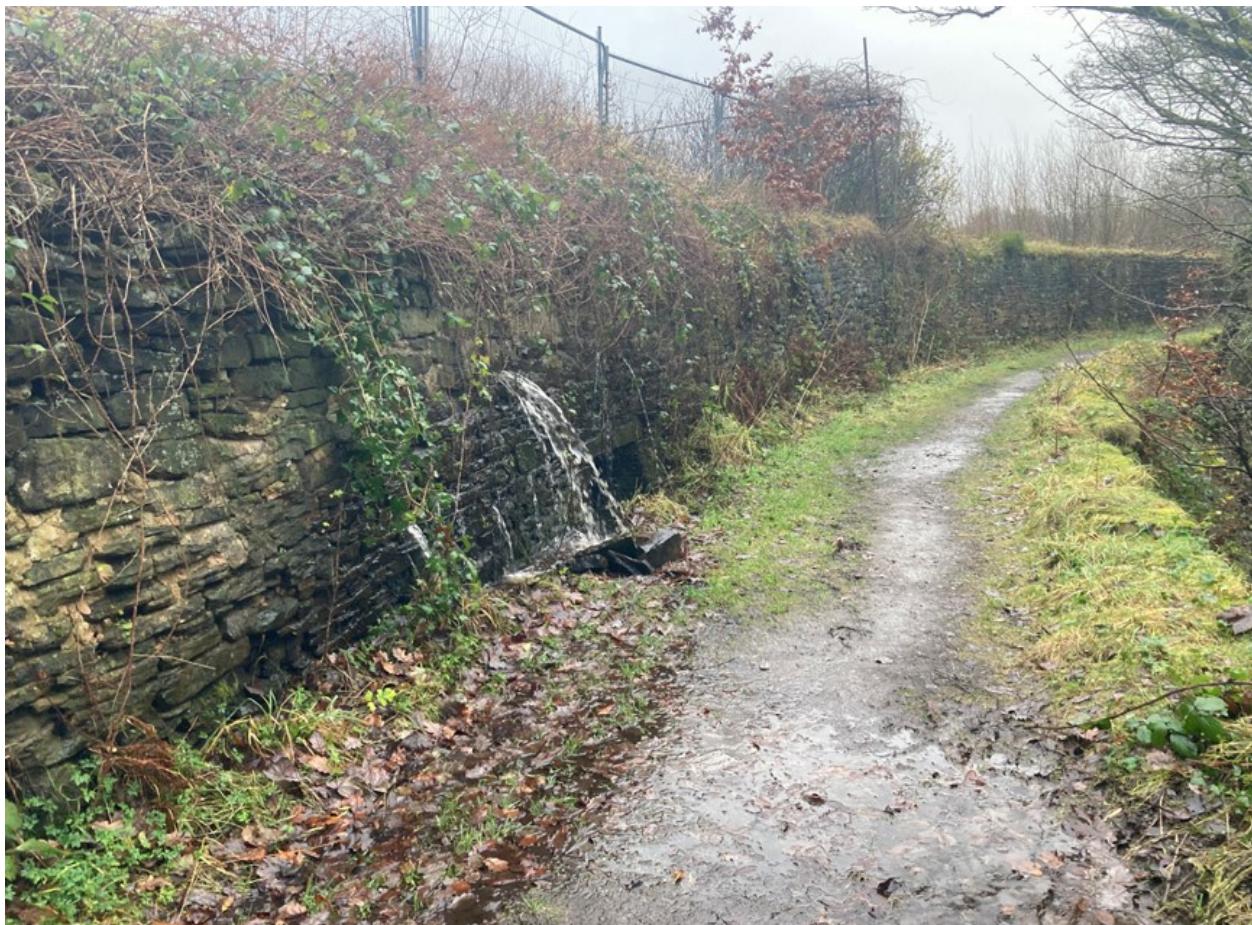
This incident occurred at an unregistered SRR. An operative from an undertaker of a nearby LRR noticed water from the SRR running through a wall and over the towpath into a canal. There was also significant leakage through an embankment and into the river. The operative contacted the Environment Agency incident team. Local Environment Agency staff attended site and confirmed the wall was bulging and leaking. As this site was unregistered, there was no knowledge of design, maintenance or any surveillance. Attempts to contact a potential landowner were unsuccessful.

- Internal erosion (adjacent to structures)
- Settlement / deformation (outside normal or expected parameters)

SRR can pose risks to local infrastructure and the public. Although not required by law, they should be maintained appropriately to reduce risks of failure.
