Case ID#

3266

Collapse of a brick outlet culvert

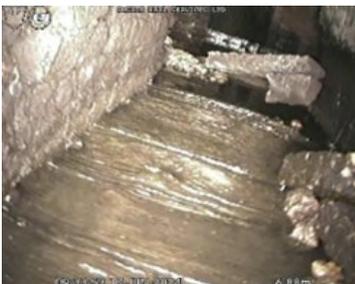
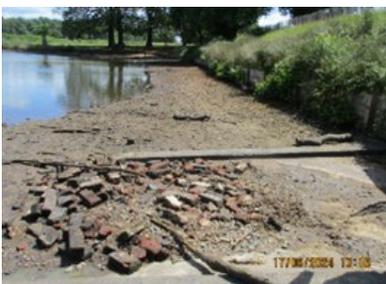
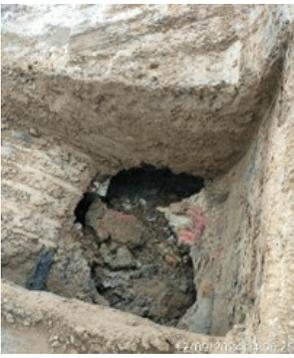
During the routine 6 monthly testing of the penstock valve, on the upstream end of an overflow culvert at an upper pond a large amount of brick rubble was carried through in the discharge to the lower pond. The penstock valve was immediately closed. The overflow culvert runs through the centre of the earth embankment dam and is 32 m in length. The upstream 20 m comprises a circular 530 mm dia concrete pipe. The final 12 m length comprised a brick arch culvert, 1080 mm high, 610 mm wide. There were no visible signs of embankment movement or crest settlement. A CCTV survey was undertaken, entering the culvert from the downstream end only, which identified a large void in the brick culvert section 8 m from the downstream end of the culvert. This survey also identified that the invert of the brick culvert comprised timber sleepers. Following consultation with the last Inspecting Engineer, a precautionary and controlled drawdown commenced. A further CCTV survey was completed, entering the culvert from both upstream and downstream ends, to help ascertain further information for the most appropriate repair. This revealed the full scale of the void, approximately 3 m in length and extending approximately 1.5 m away from either side of the original line of the brick culvert. The crest path was closed to both pedestrian and vehicular traffic and temporary pumps were brought in to continue the pre-cautionary drawdown at a rate of between 300 and 400 mm per day and hold the water level at an agreed level whilst a design solution was developed and repairs to the overflow were undertaken.

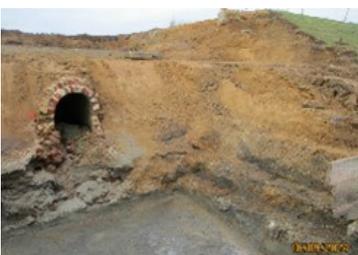
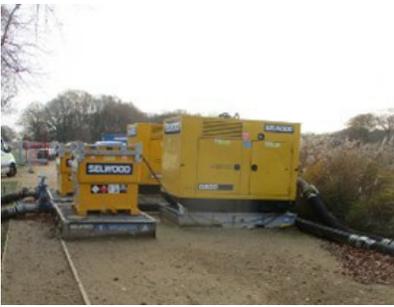
The root cause of the incident was failure of the brick culvert overflow leading to potential instability of the homogeneous earth embankment dam.

- Failure or damage to tunnel or culvert
- Internal erosion (adjacent to structures)
- Internal erosion (fill deterioration)
