3268

Unpermitted excavation on a flood storage reservoir

537

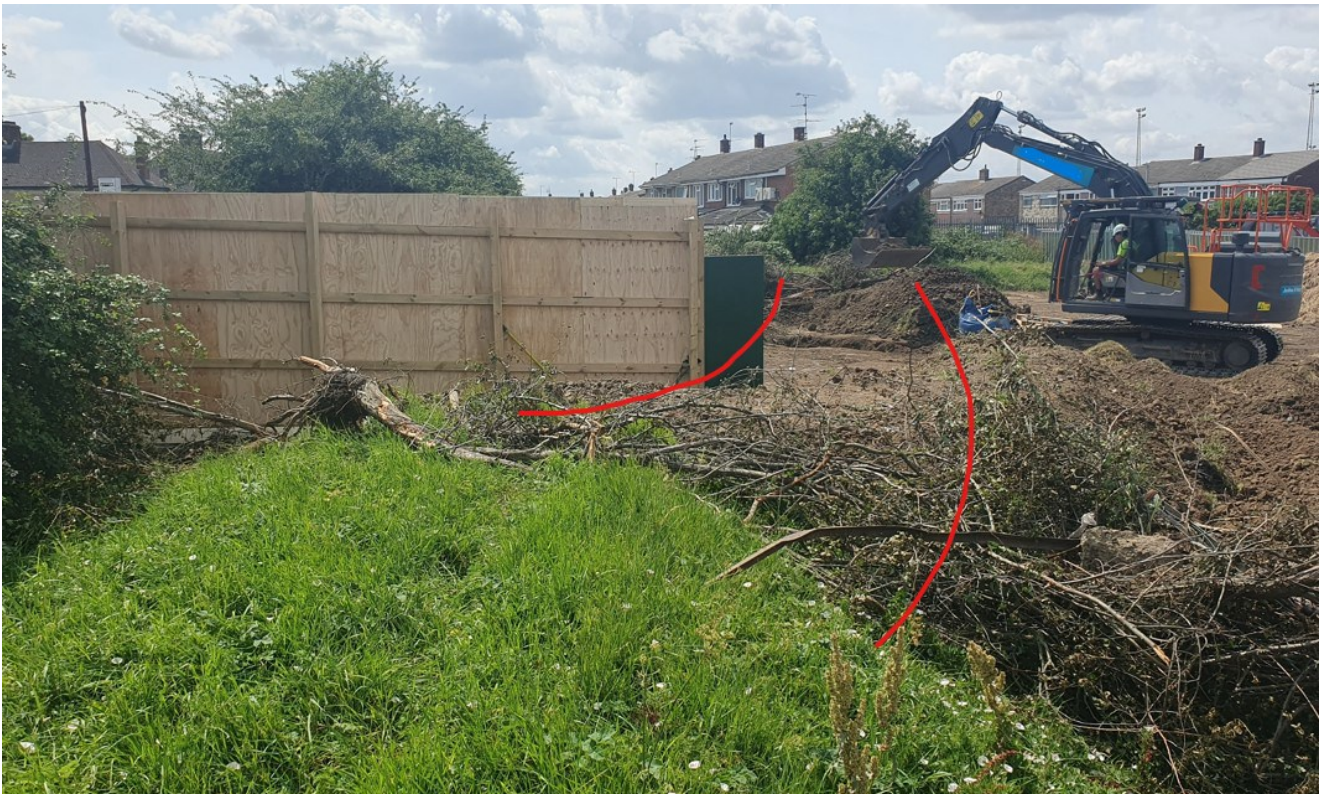
During routine maintenance works, the undertaker of a flood storage reservoir noticed that someone had excavated into the dam. A contractor working on behalf of a developer had removed a section of the bank. The undertaker notified the supervising engineer and investigated the cause. The undertaker and supervising engineer visited the contractor within 24 hours. They instructed them to stop all works and reconstruct the embankment. The reconstruction was completed under supervision of the supervising engineer. The available documents on the Local Planning Authority website did not make it clear what the exact approved details for works on the dam were. The Environment Agency had been formally consulted, and they had provided details of their required conditions. Work on site suggested the contractor was not aware of the required conditions. The situation appears to have occurred by a lack of suitable communication. The undertakers have since discussed with the planning authority: how the incident was able to occur what corrective actions should be taken measures to prevent a reoccurrence.

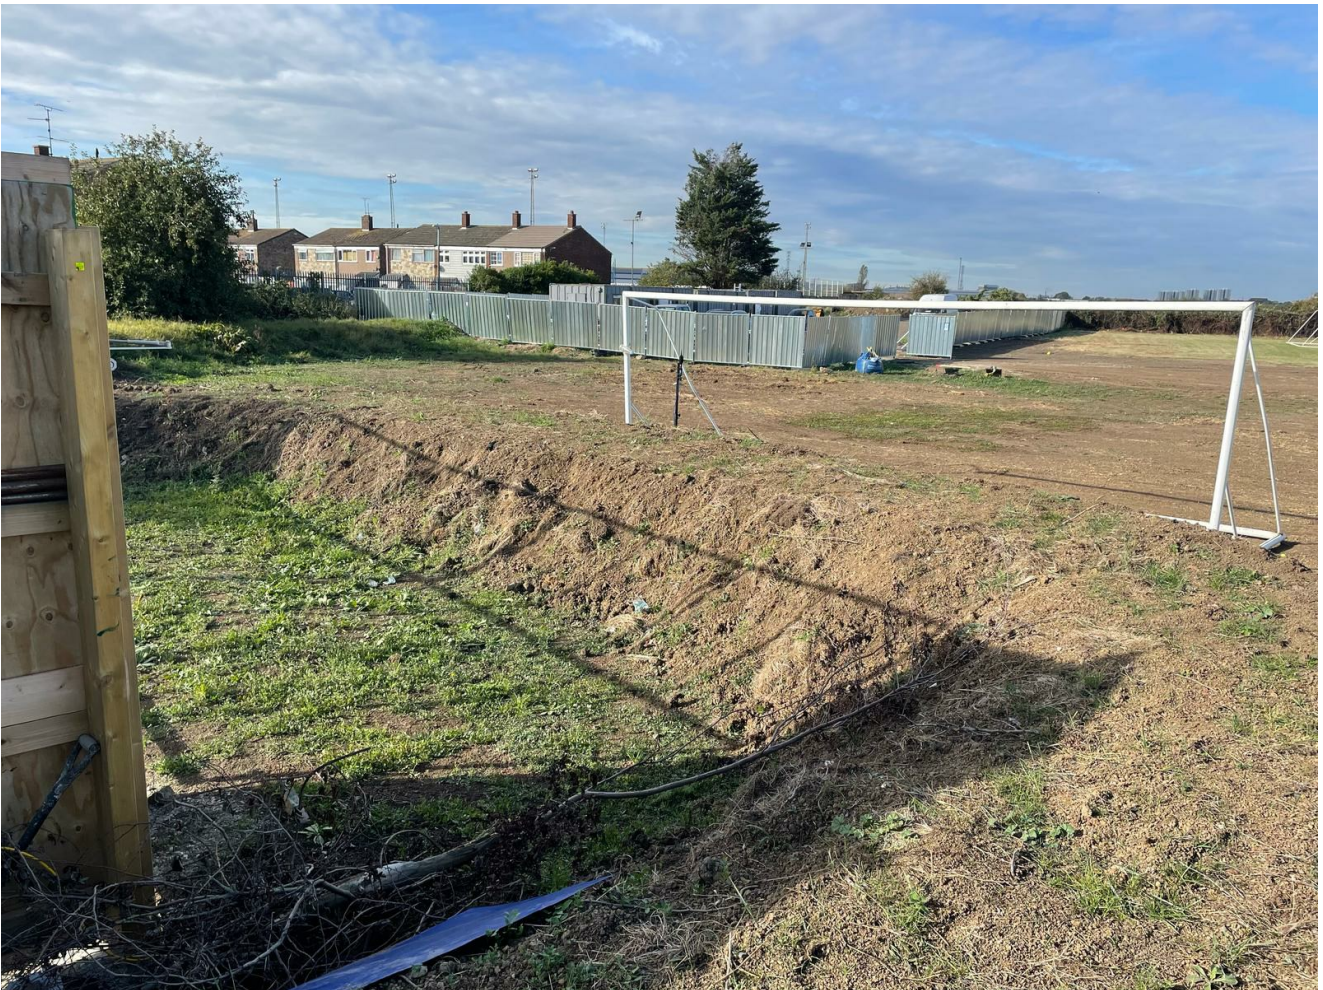
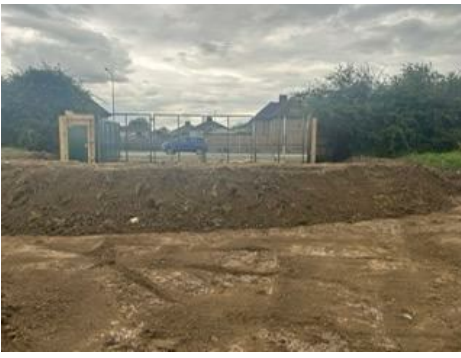
- Other external factors (describe below)

- Process or procedural shortcoming

- External erosion

Rapid attendance of undertaker and SE to construction site and instruction to cease works, and reinstate bank.
