Case ID#

3269

Longitudinal cracking of a thick topsoil layer on an embankment dam did not self heal, leading to a translational slip

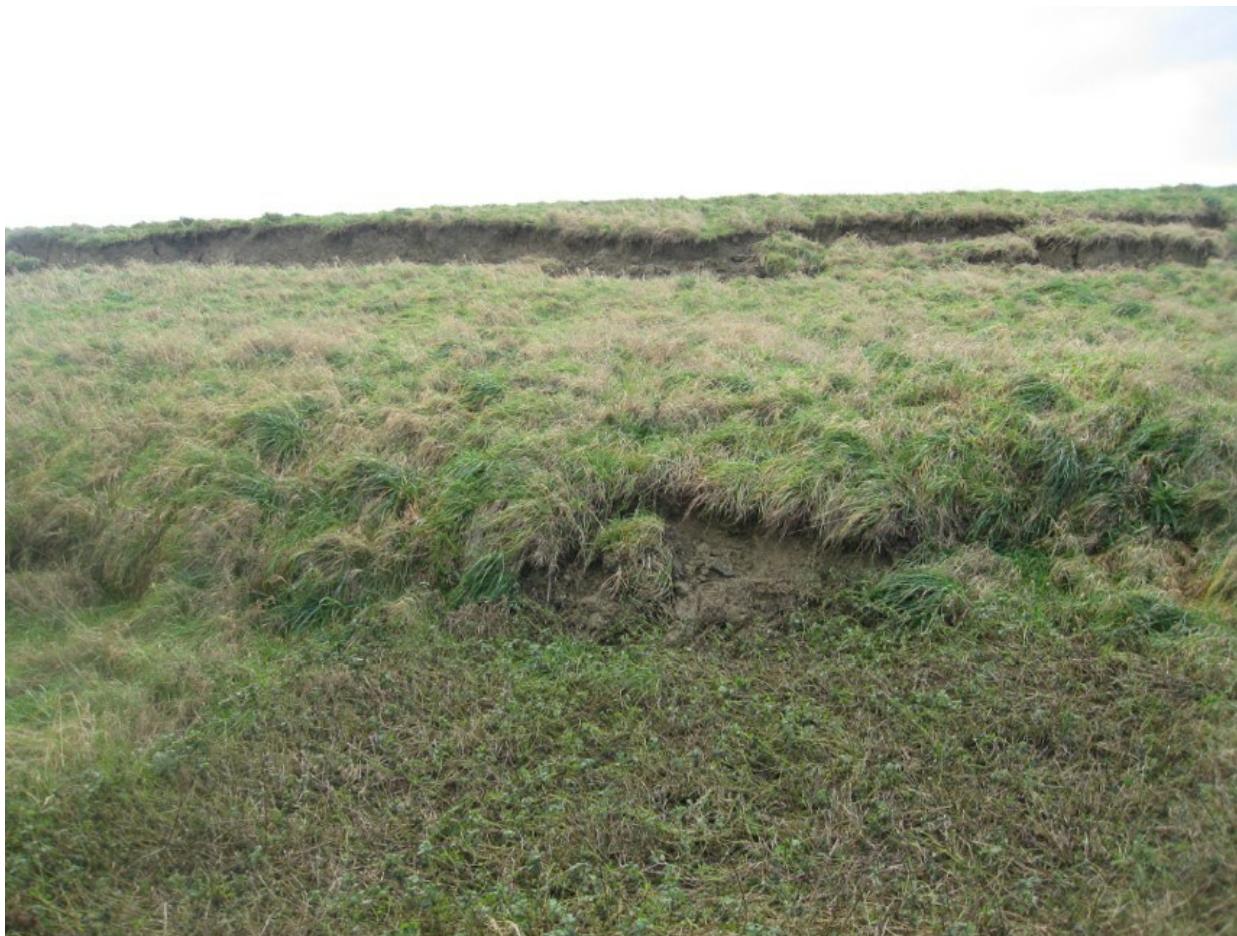
On the morning of 6th January estate personnel observed that a slip had occurred on the downstream face of the northern embankment of the reservoir. The area was visually inspected; it was observed that there was no clear ongoing movement or discharge of water, but that the toe area around the entire embankment perimeter was very wet (this is consistent with very heavy rainfall of approximately 60mm on the evening of 5th January). The Undertaker's representative was contacted, and he then advised the Supervising Engineer. The Supervising Engineer visited the site on 6th January and discussed his findings with the Undertaker and QCE. A summary of the site visit notes is below: Reservoir level -10.8 on the ramp (I estimate around 2.5m below TWL) The area of the slip on the downstream face is approx. 80m length at the western end of the northern bank. No signs of movement or of extensive longitudinal cracking on the remaining perimeter. At the area of the slip the upstream face and crest appear undisturbed, slip extends from approx. downstream edge of the crest to approx. 2m upslope from the toe. No signs of increased seepage or other distress and the rotational component of the movement appears pretty small so appears to be a relatively shallow slip perhaps 1 to 2m deep in places. Note this would be consistent with this being entirely within the non-structural additional topsoil thickness noted in the annex to the CoEEoW. Crest width in this location was measured at 9m this is significantly wider than the nominal 4m shown in the record drawings in the annex to the CoEEoW so suggests the topsoil wedge could be up to 2m thick. During construction it is understood that there was a significant surplus volume of topsoil / subsoil material from the reservoir footprint that was unsuitable for use as structural embankment fill. According to the Annex to the Certificate of Efficient Execution of Works, this material was placed on the downstream shoulder of the embankment; investigations following the incident indicate that the thickness of material placed was approximately 1.5m to 2m. The last S10 report (2018) notes that "The crest carries a significant thickness of topsoil which has desiccated during the recent and prolonged wet weather. I consider that these cracks will self-heal when the autumn/winter rains come and moisture contents rise. If the cracks do not "heal" then I recommend that the cracks be filled with a dry sand/topsoil/grass seed mix poured into the fissures." The Supervising Engineer has subsequently observed desiccation cracking on the crest and downstream face; however, this has typically self-healed in the autumn/winter. It appears that there was a longitudinal desiccation crack along the downstream face of the northern embankment, just below the crest, that did not self-heal over the autumn of 2024. During the exceptionally heavy rainfall of the evening of 5th January 2025, this crack filled with water, resulting in lubrication of the interface between the non-structural topsoil and the clay fill beneath. This caused a translational failure of the ~1.5m to 2m thick topsoil wedge. A section of embankment approximately 80m in length was affected, and the topsoil wedge moved downslope by approximately 2m.

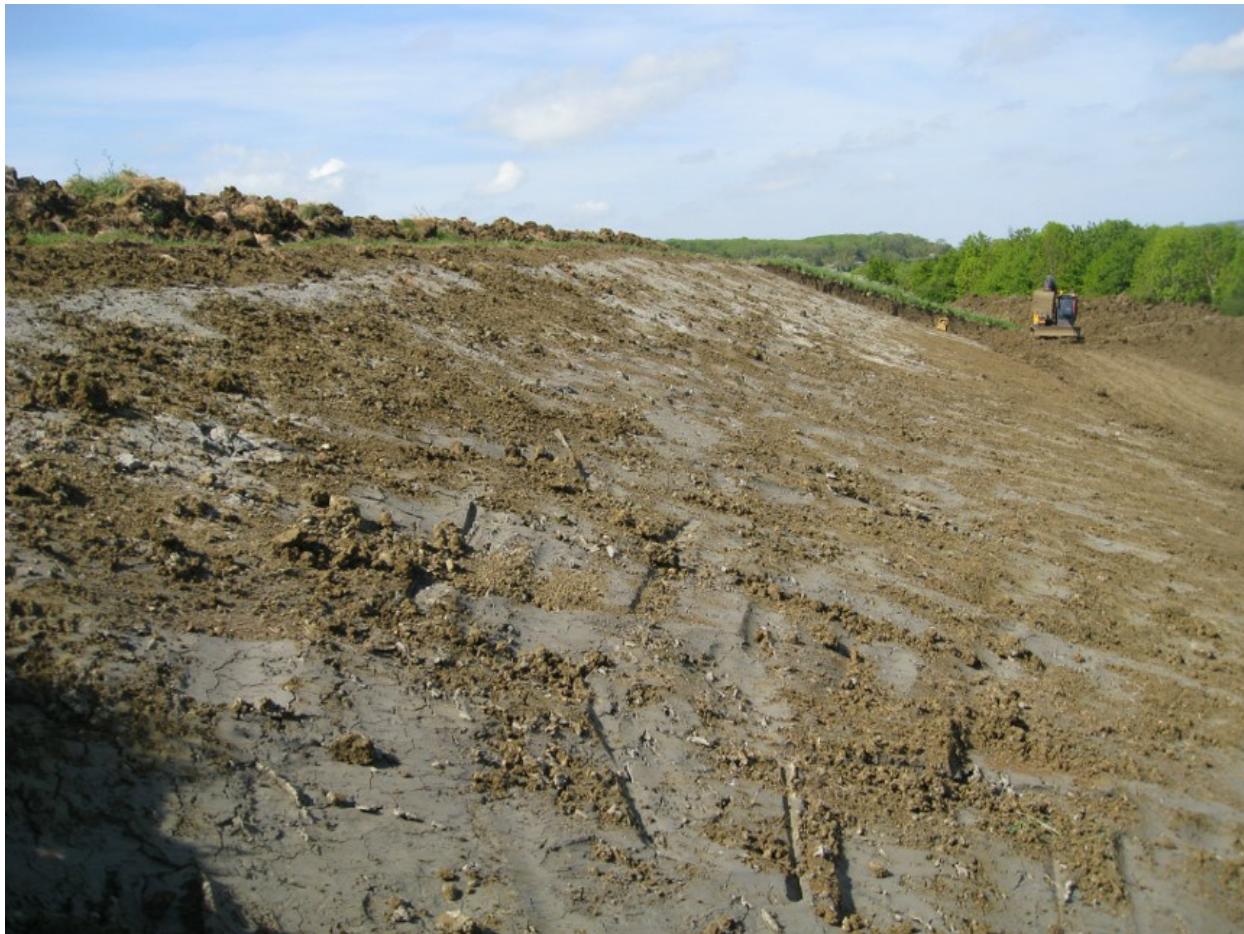
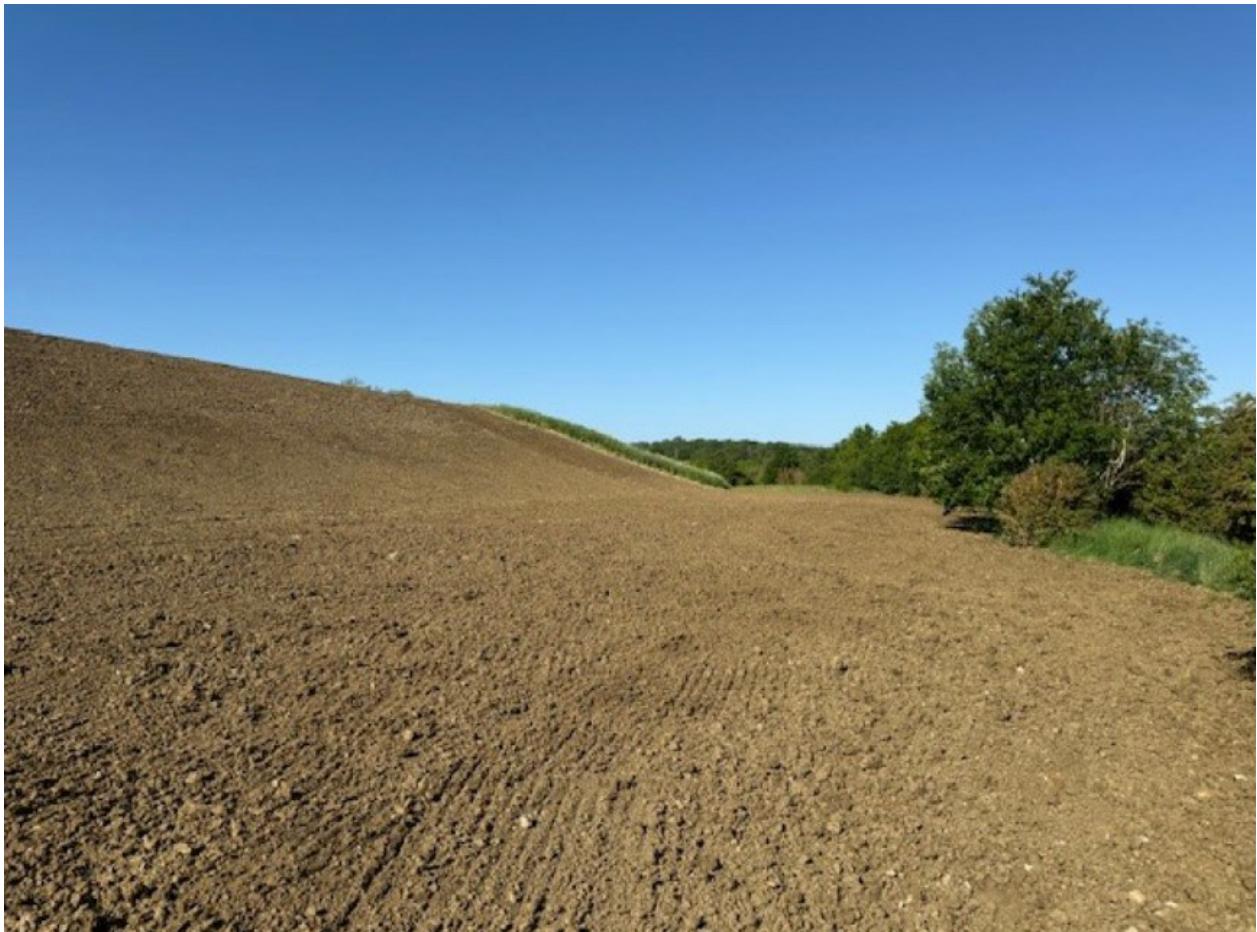
During construction it is understood that there was a significant surplus volume of topsoil / subsoil material from the reservoir footprint that was unsuitable for use as structural embankment fill. According to the Annex to the Certificate of Efficient Execution of Works, this material was placed on the downstream shoulder of the embankment; investigations following the incident indicate that the thickness of material placed was approximately 1.5m to 2m. The last S10 report (2018) notes that "The crest carries a significant thickness of topsoil which has desiccated during the recent and prolonged wet weather. I consider that these cracks will self-heal when the autumn/winter rains come and moisture contents rise. If the cracks do not "heal" then I recommend that the cracks be filled with a dry sand/topsoil/grass seed mix poured into the fissures." The Supervising Engineer has subsequently observed desiccation

cracking on the crest and downstream face; however, this has typically self-healed in the autumn/winter. It appears that there was a longitudinal desiccation crack along the downstream face of the northern embankment, just below the crest, that did not self-heal over the autumn of 2024. During the exceptionally heavy rainfall of the evening of 5th January 2025, this crack filled with water, resulting in lubrication of the interface between the non-structural topsoil and the clay fill beneath. This caused a translational failure of the ~1.5m to 2m thick topsoil wedge. A section of embankment approximately 80m in length was affected, and the topsoil wedge moved downslope by approximately 2m.

All slipped material was removed and the downstream face reinstated by placing 200mm depth of topsoil. Surplus material placed in a low berm at the toe of the embankment, with cross-fall away from the embankment to provide surface water drainage and prevent ponding at the embankment toe. The reduction in topsoil thickness at the location of the slip reduces the likelihood of a similar slip reoccurring in this location. It is noted that non-structural topsoil / subsoil thickness of 1.5m to 2m remain around the rest of the reservoir embankments; as there has been no mass movement in these areas no works have been undertaken. Surveillance to be implemented by the Undertaker and Supervising Engineer to monitor for persistent longitudinal dessication cracks that do not self-heal in Autumn.
