3342

Scour damage to spillway channel following storms

Wales

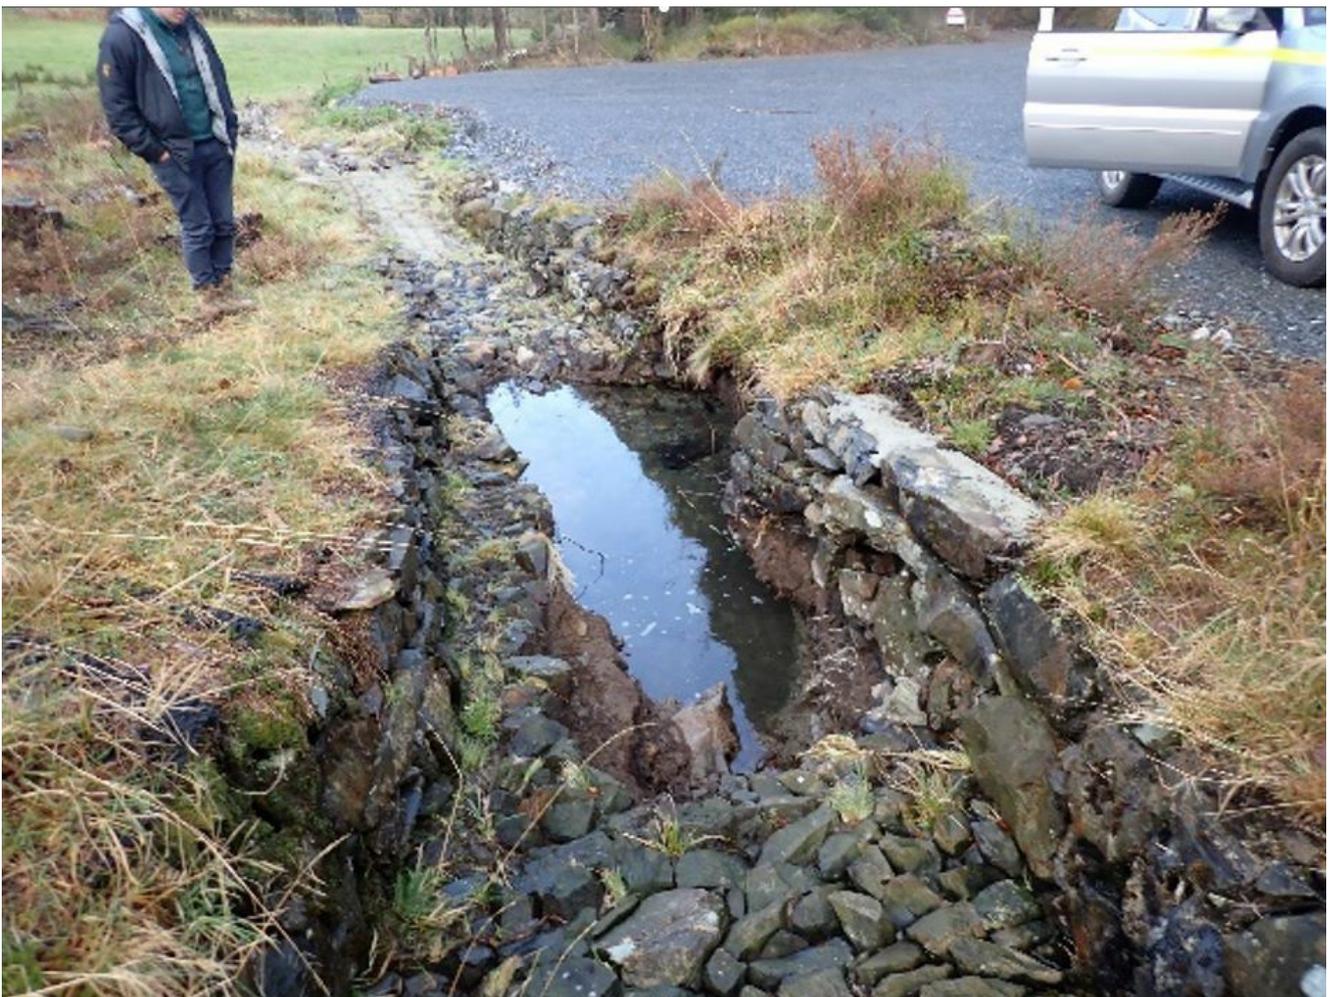
Following routine surveillance, the Supervising Engineer was alerted of scour dam to the old narrow masonry spillway channel following storms in early January 2025 and resulting in reservoir impoundments. The hole in the spillway started at around 4pm from the upstream entrance of the spillway, which was approximately 4.5m in length / 1.5m in width and around 1m deep. SE attended site and initiated telephone discussions with the QCE. Remedial works were agreed on later that day, including MIOS improvement works to replace the existing spillway.

Old narrow and inadequate masonry spillway channel deteriorating following storm / flood events, leading to scour damage.

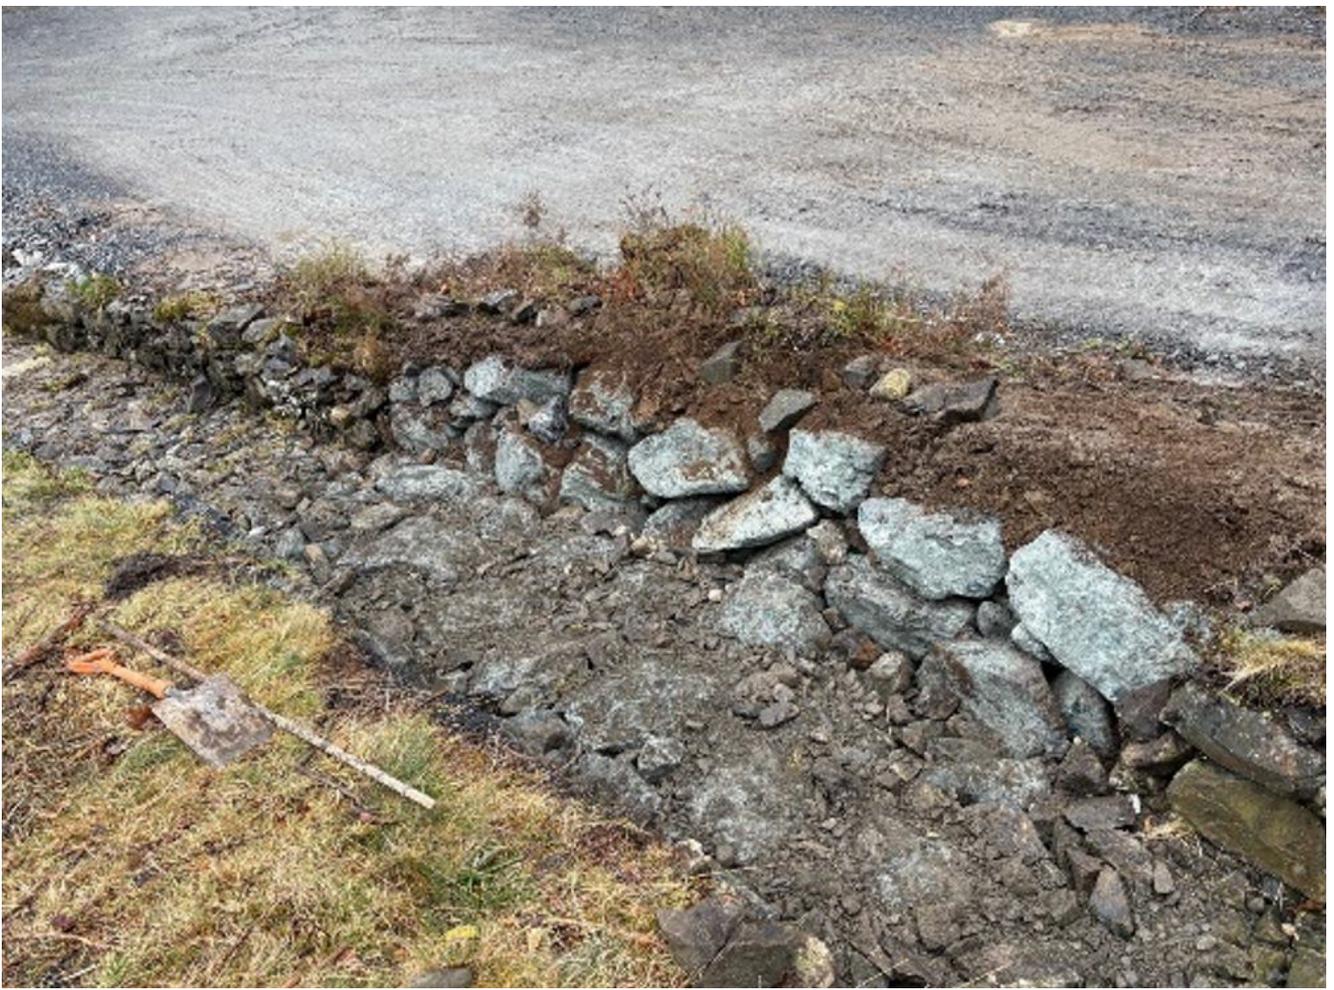
- Spillway or overflow - failure or instability

Effectiveness of permanent measures :- the new spillway facilities and channel were successfully tested during a heavy rainfall event (albeit at a very low water level compared to the safety check flood level) in September 2025, with a water depth of 140mm observed flowing through the new main spillway structure and channel.
