3342

Scour damage to spillway channel following storms

Wales

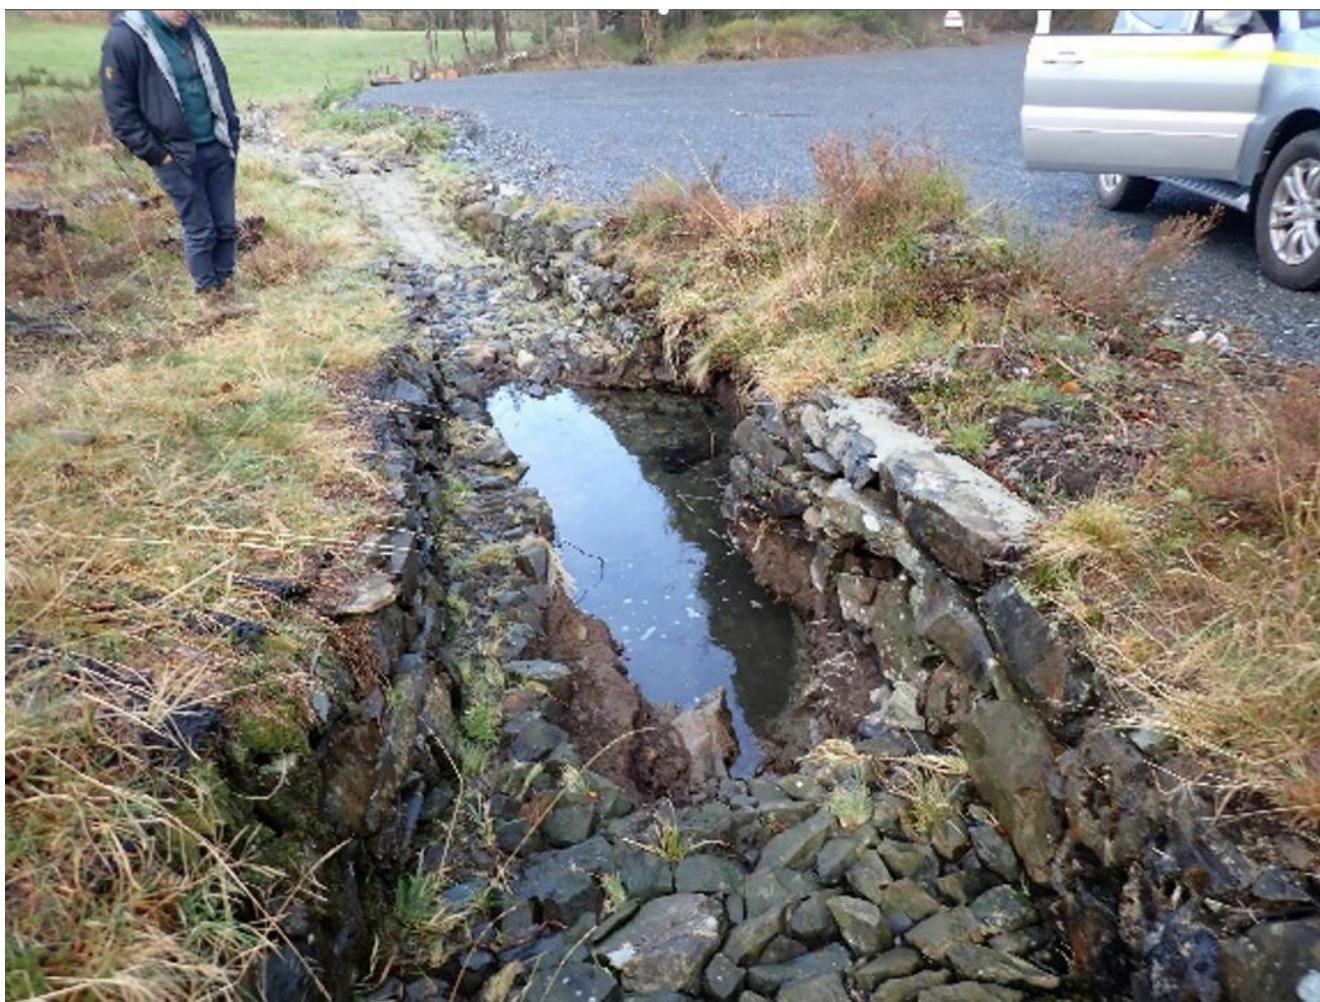
Following routine surveillance, the Supervising Engineer was alerted of scour dam to the old narrow masonry spillway channel following storms in early January 2025 and resulting in reservoir impoundments. The hole in the spillway started at around 4pm from the upstream entrance of the spillway, which was approximately 4.5m in length / 1.5m in width and around 1m deep. SE attended site and initiated telephone discussions with the QCE. Remedial works were agreed on later that day, including MIOS improvement works to replace the existing spillway.

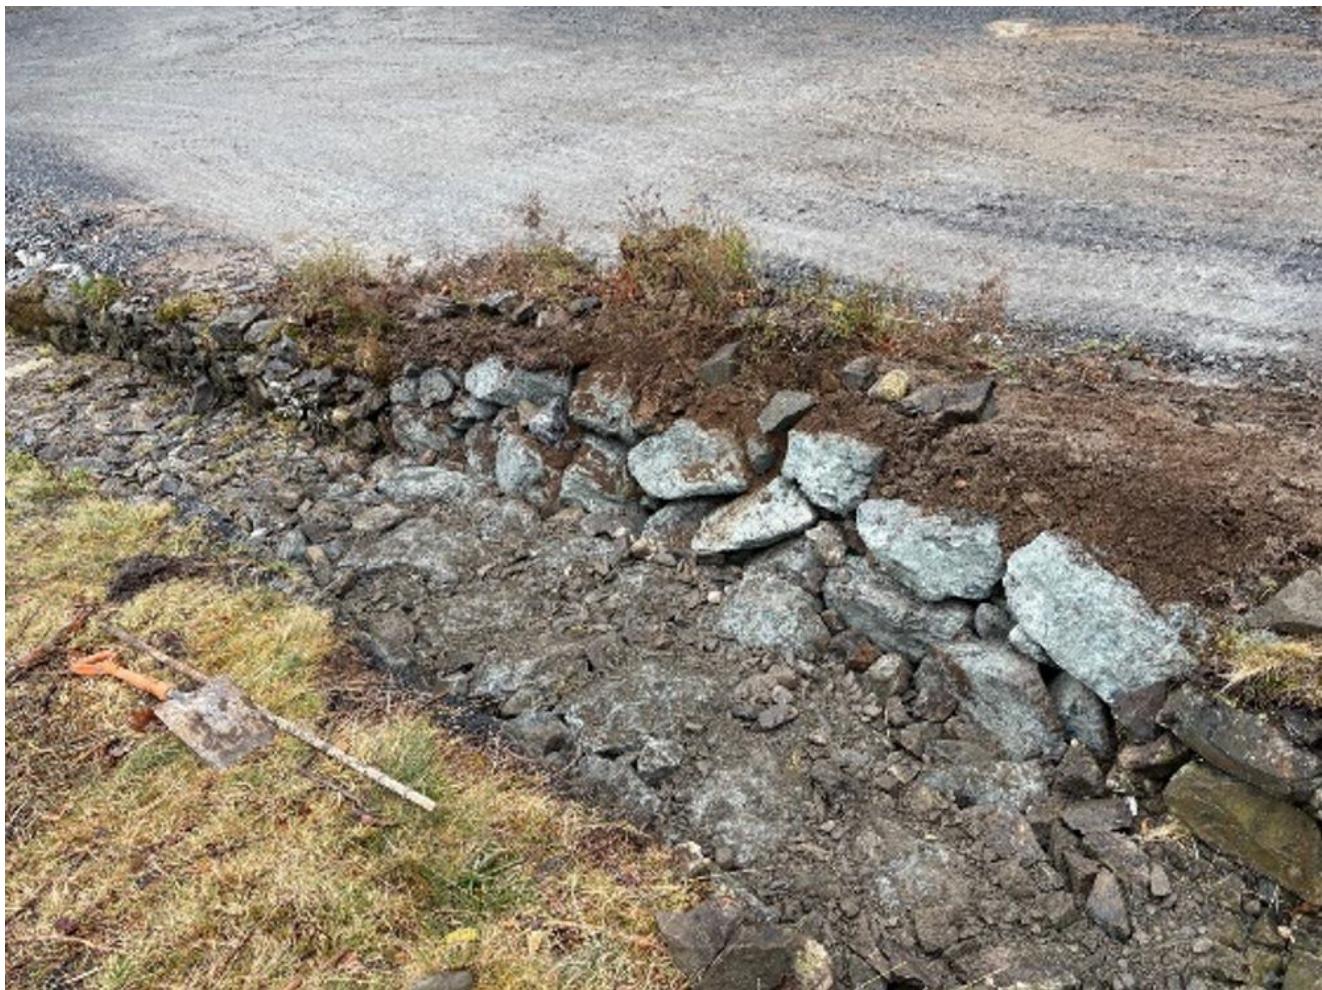
Old narrow and inadequate masonry spillway channel deteriorating following storm / flood events, leading to scour damage. Effectiveness of permanent measures :- the new spillway facilities and channel were successfully tested during a heavy rainfall event (albeit at a very low water level compared to the safety check flood level) in September 2025, with a water depth of 140mm observed flowing through the new main spillway structure and channel.

- Spillway or overflow - failure or instability
