28 October 2025

3345

Partial failure of outlet pipe leading to internal erosion in flood storage reservoir, exacerbated by a blocked debris screen

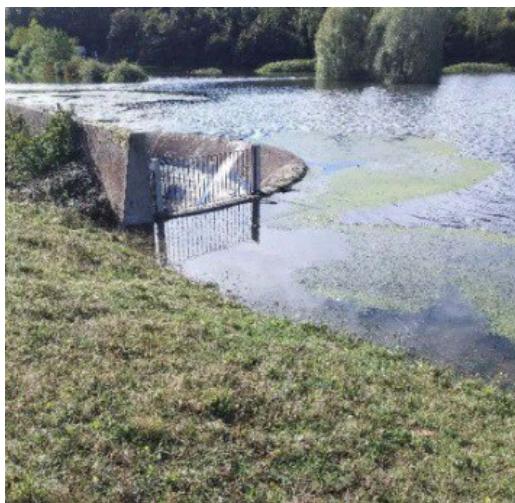
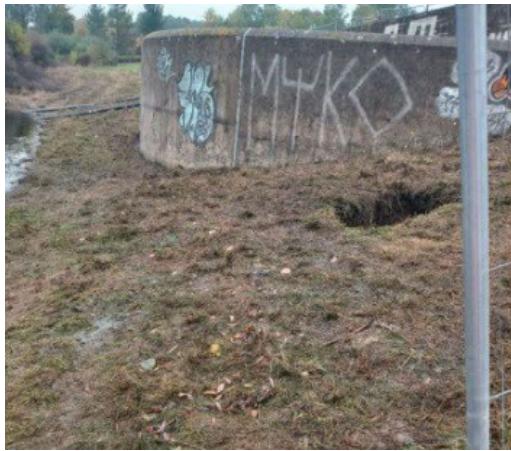
Following a significant rainfall event, the flood storage reservoir impounded higher than is usual and remained impounded longer than would be expected. Although the flood storage reservoir operated as it was designed, a significant amount of grass cuttings had been washed down the system and had subsequently reduced the capacity of the outlet pipe by approx. 50%. Although not a dam safety requirement at the time, the undertaker operations team proceeded to install simple siphons to help reduce the water level. On reducing the water level, the staff observed a sink hole approx. 3m W x 3m L x 1m D located above the alignment of the outlet pipe and on the upstream face. Additional rainfall was forecast and the previous inspecting engineer could not attend so a more local ARPE attended site on 14th October 2024 pm (now appointed as QCE). Visual assessment was conducted by ARPE and Supervising Engineer on 14th October 2024 with recommendations to lower reservoir levels immediately, carry out a CCTV of the outlet, clear inlet screen from vegetation/grass using divers to allow full flow of the outlet conduit. Continuous assessment of the weather forecast was also advised. The Emergency resilience team of the undertaker were advised of the need to declare an incident and move the status of the incident to standby (or alert) status. As per the onsite plan requirements at standby alert status, a member of the supervising engineers panel advised following visual inspection there was no need to move the incident alert status to advisory. Observations at the site are being made daily. Any changes in the embankments condition will be brought immediately to the Reservoir Safety Teams attention for any further actions required.

A previously unknown failure of the outlet pipe caused internal erosion, where fines were washed down causing a sinkhole on the upstream face of the dam. A blocked debris screen from grass cuttings on the outlet meant the flood storage reservoir was held at a higher level than normal. This triggered investigation of the condition of the outlet pipe and identification of the partial failure of the pipe.

The installation of siphons (5 No. 100mm rigidrain pipes manually primed over and into the overflow) helped reduce the water level until sink hole was observed, and then pumps were installed to reduce levels quicker.

Once water levels had reduced, divers were employed to clear the outlet grill.
