3347

Assessment of unexplained reservoir water loss: Incident response and ongoing integrity investigation (not high-risk reservoir)

Earth fill embankment

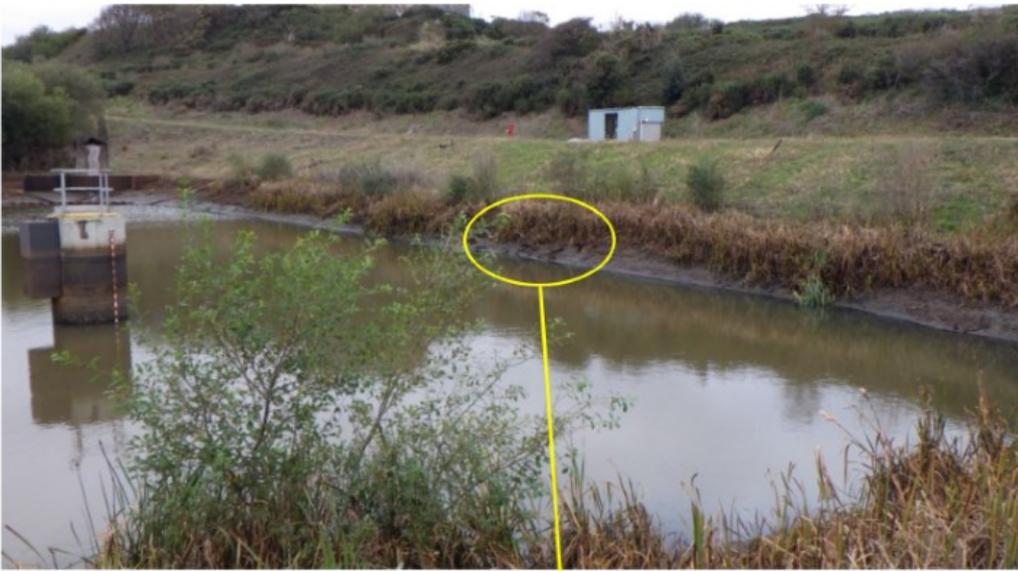
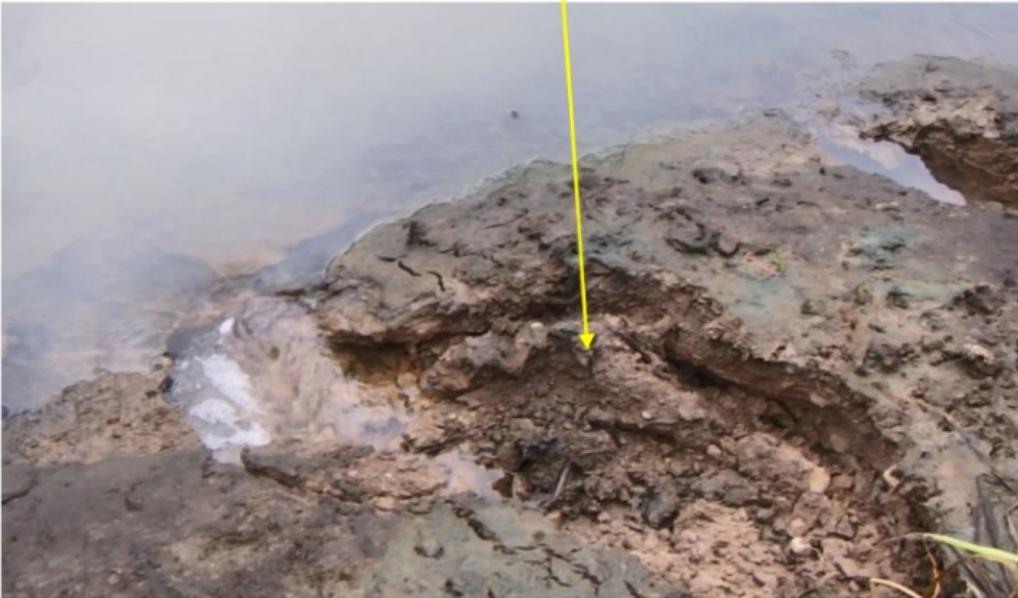
It was observed that the reservoir was not maintaining its normal operating water level. No specific trigger was identified. Historical incidents in 2019 and 2022 showed similar symptoms (unexplained water loss). Following a more recent investigation, a possible defect in the upstream embankment was observed following a spring tide. The defect became submerged following heavy rain. A boom has been installed upstream of the defect until temporary and/or permanent repairs can be carried out.

Drone survey (inconclusive). Dye testing of underdrainage catch boxes. Visual inspection during low water levels. Planned further investigation and repair in mid-2026.
