3352

Sluice Gate Failure at Flood Storage Reservoir – Emergency Response and Remedial Actions

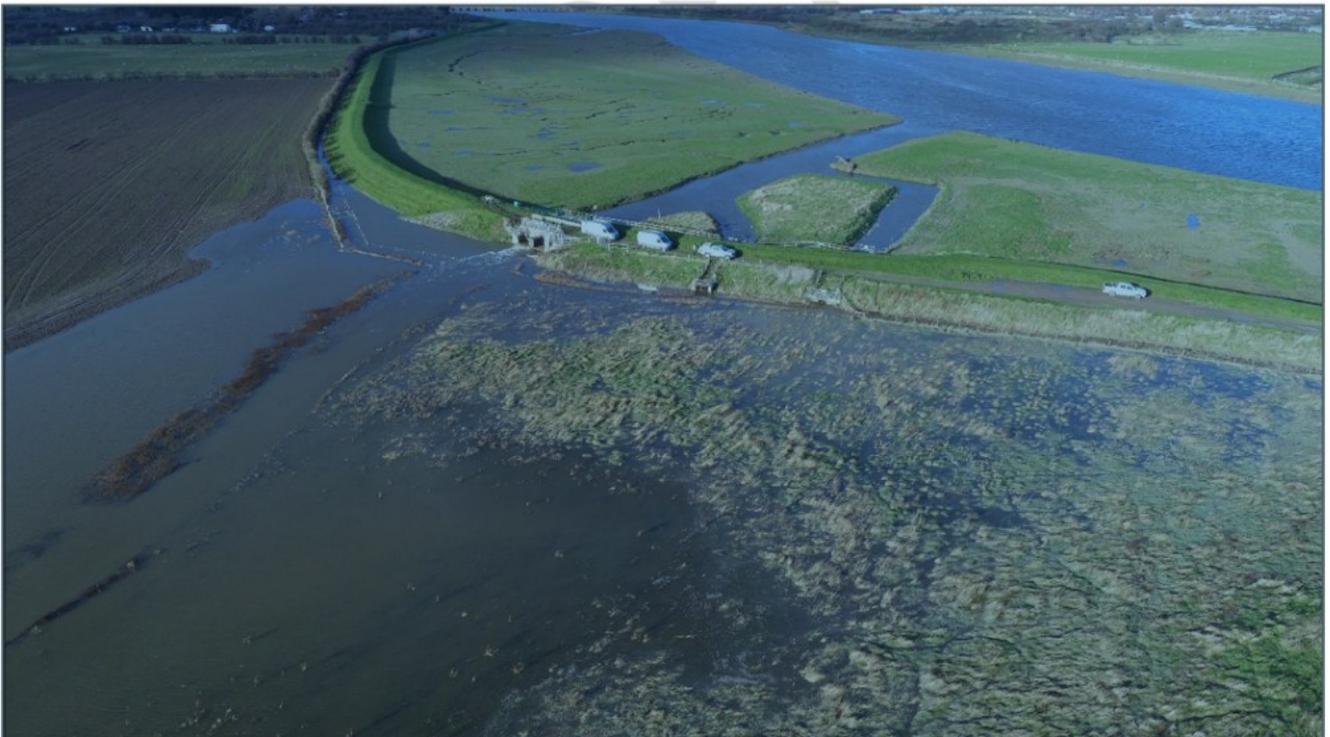
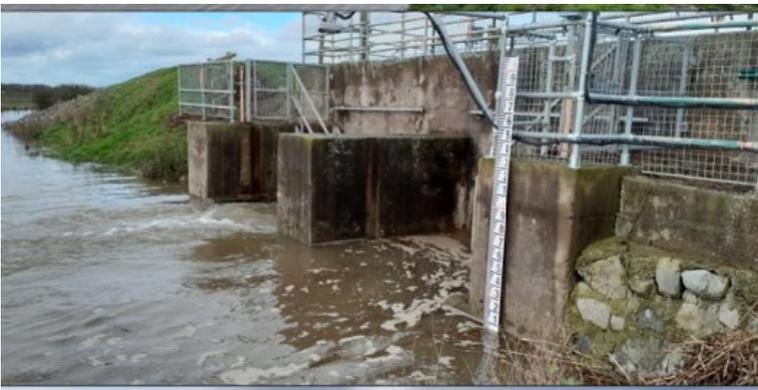
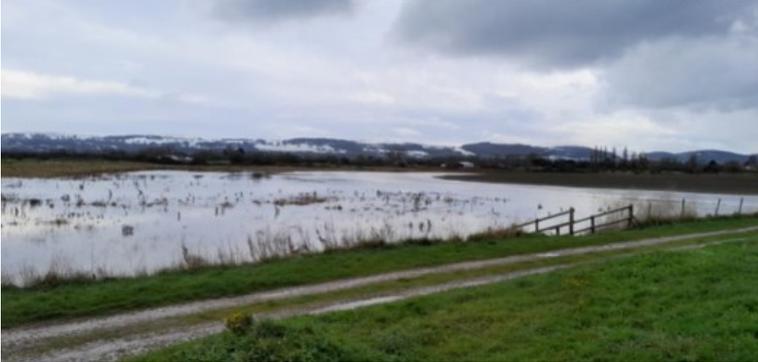
Undertaker was notified of an ingress of water on land upstream of the main embankments. On inspection it was apparent that a tidal sluice gate had detached completely allowing an ingress of water onto fields behind the embankments during high tides. While the sluice gate did not directly release water, the 2016 Regulations (Wales) require reporting where an incident 'could result' in an uncontrolled release and where emergency measures are taken to prevent escalation.

Corrosion and wear of sluice gate bolts over decades, leading to detachment during high tide.

None: Bi-annual asset inspections and monthly checks by undertaker; statutory Section 10 and Section 12 reports by qualified engineers. Visual inspections were regular but did not prevent failure; post-incident improvements include installation of cameras for real-time monitoring.
