3355

Sinkhole adjacent to wave wall led to identification of deep void under foundation

Earth fill embankment

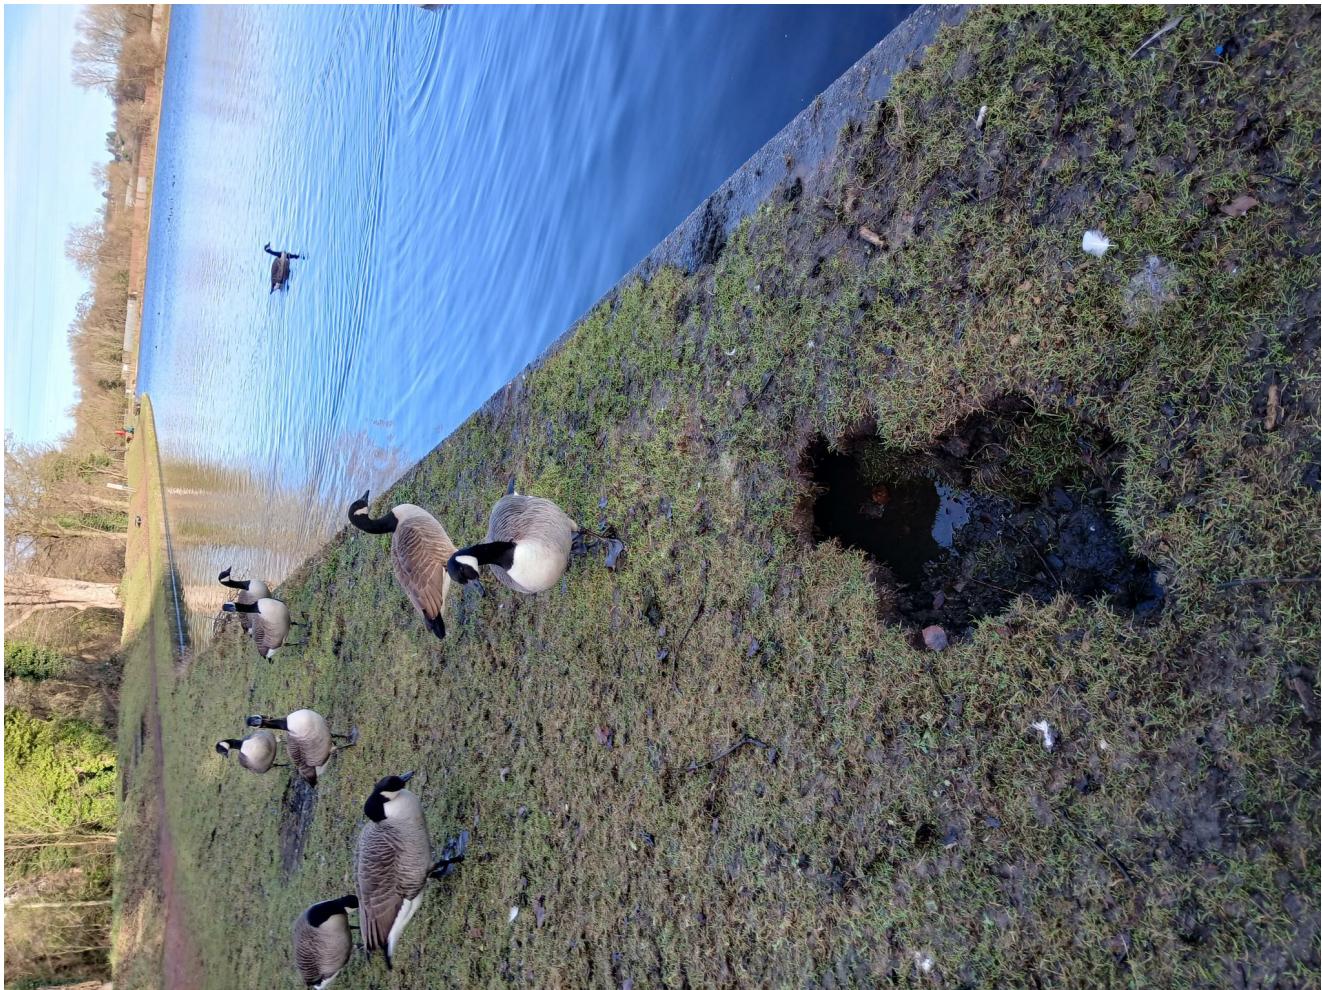
A small hole approximately 0.9m long x 0.6m wide x 0.3m deep was discovered 30.12.2024 on the west bank (dam) near the corner with the south side (not dam).

The hole was within 1 m rear of wave wall.

Sinkhole as it was found

The sink hole occurred on the site of an old demolished building, and it is suspected that the ground was not compacted correctly when it was demolished. Heavy persistent rain over autumn-winter 2024 may also of had a part to play - undercutting of the concrete wall foundation. Shallow foundation when built.

On 31.12.2024 the reservoir was inspected along with the sink hole. The water level within the reservoir had dropped to 160mm below the overflow weir and below the base of the sink hole. After discussions with the Supervising Engineer it was agreed to close the penstock but keep the water level below the level of the sink hole until the hole was filled. Arrangements were made for the sink hole to be opened out by hand initially to find the extent of the void and then to fill the hole with clay material and compacted in 150mm layers and topped with a 100mm layer of topsoil which was carried out and completed on 02.01.2025.

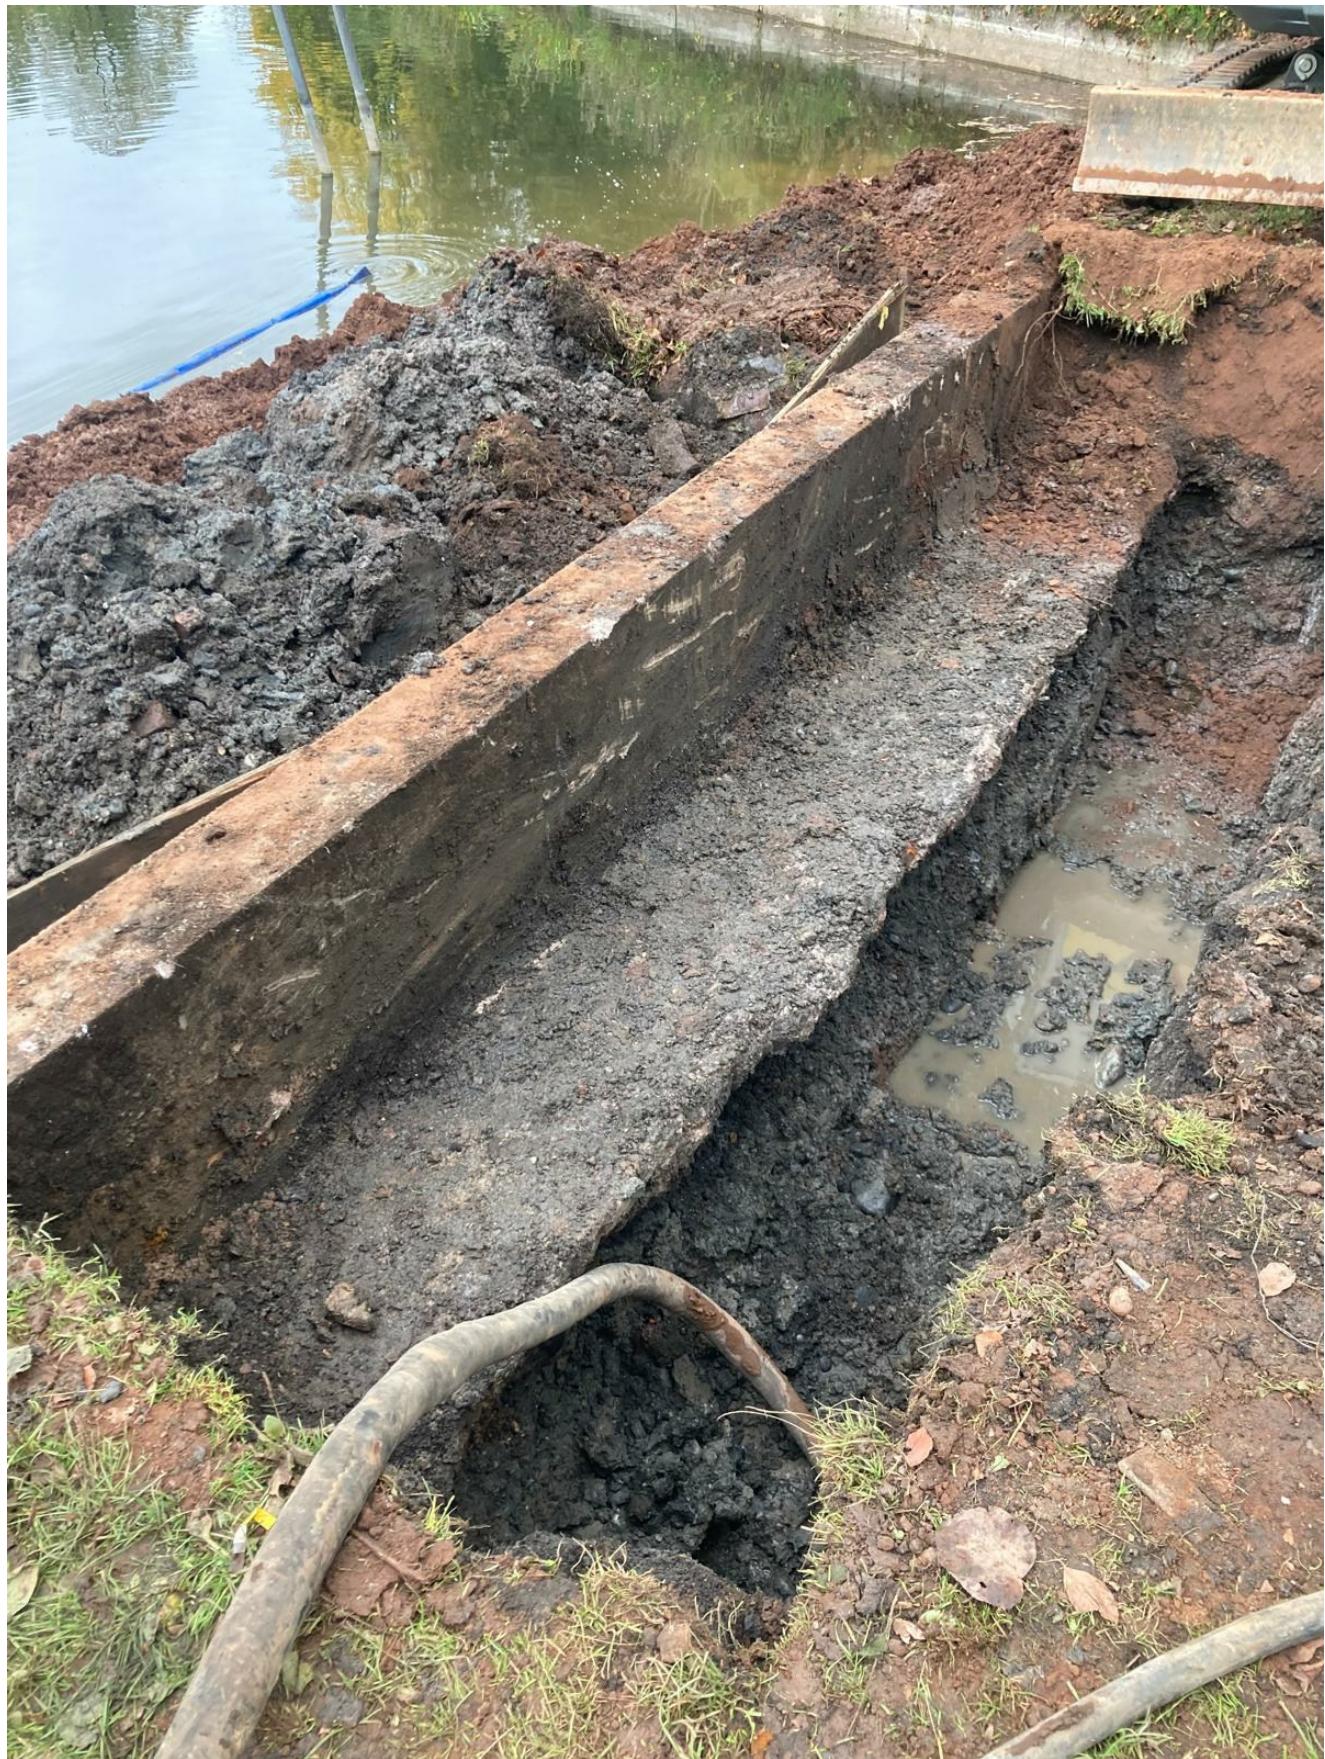
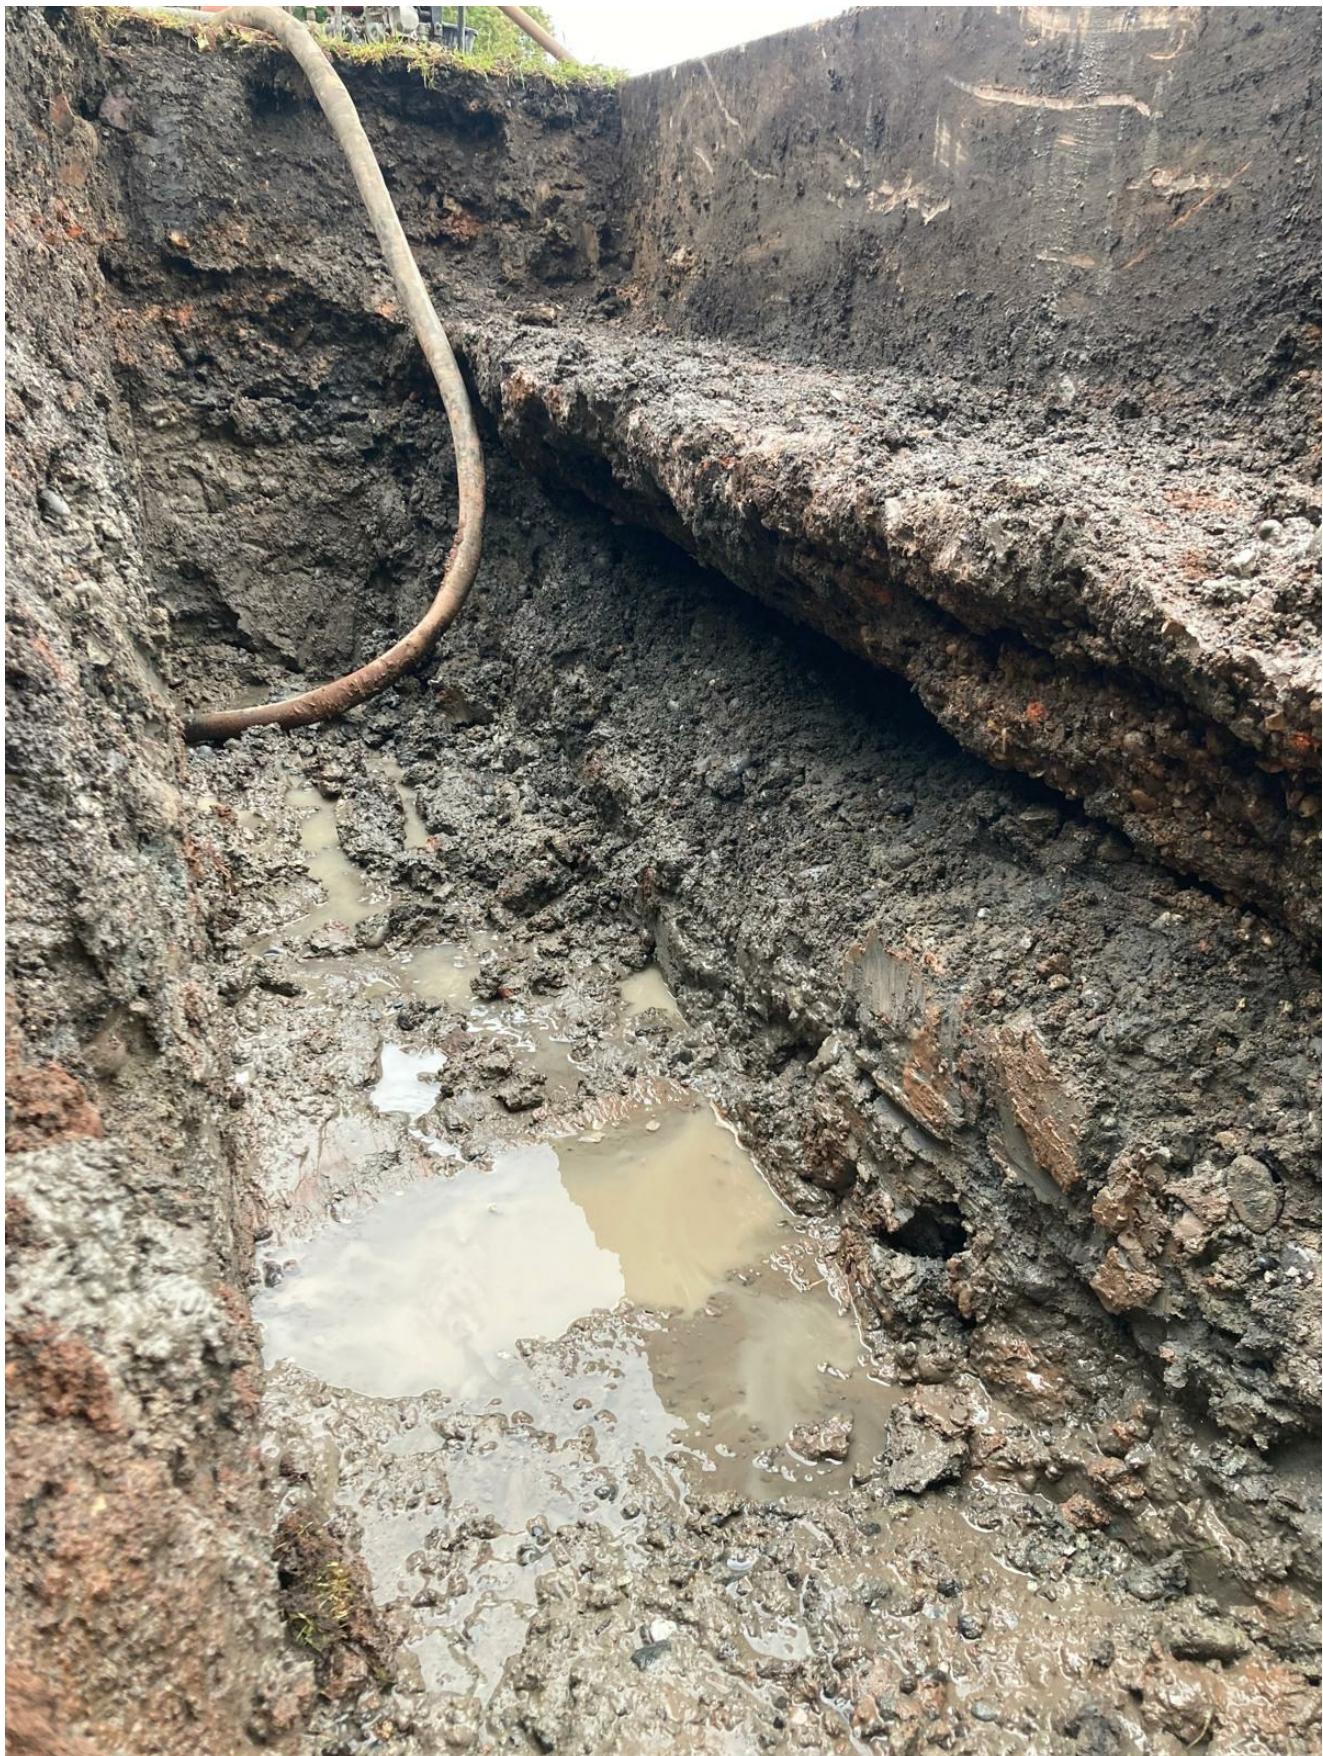
The wall was found to be in a good condition however the foundations were undermined over a length of 4.5m with a void, approximately 10cm deep by 90cm wide.

Photo showing excavated section of wall foundation and the void found

After consultation with the Supervising Engineer, it was agreed to shutter off the front of the wall foundation and excavate behind the wall at this location 4.5m long by 1m wide to a depth of approximately 1.3m deep, and to fill the excavation with C30 concrete. This work was completed on 13.10.2025 and the subsequently reinstated with topsoil and grass seed.

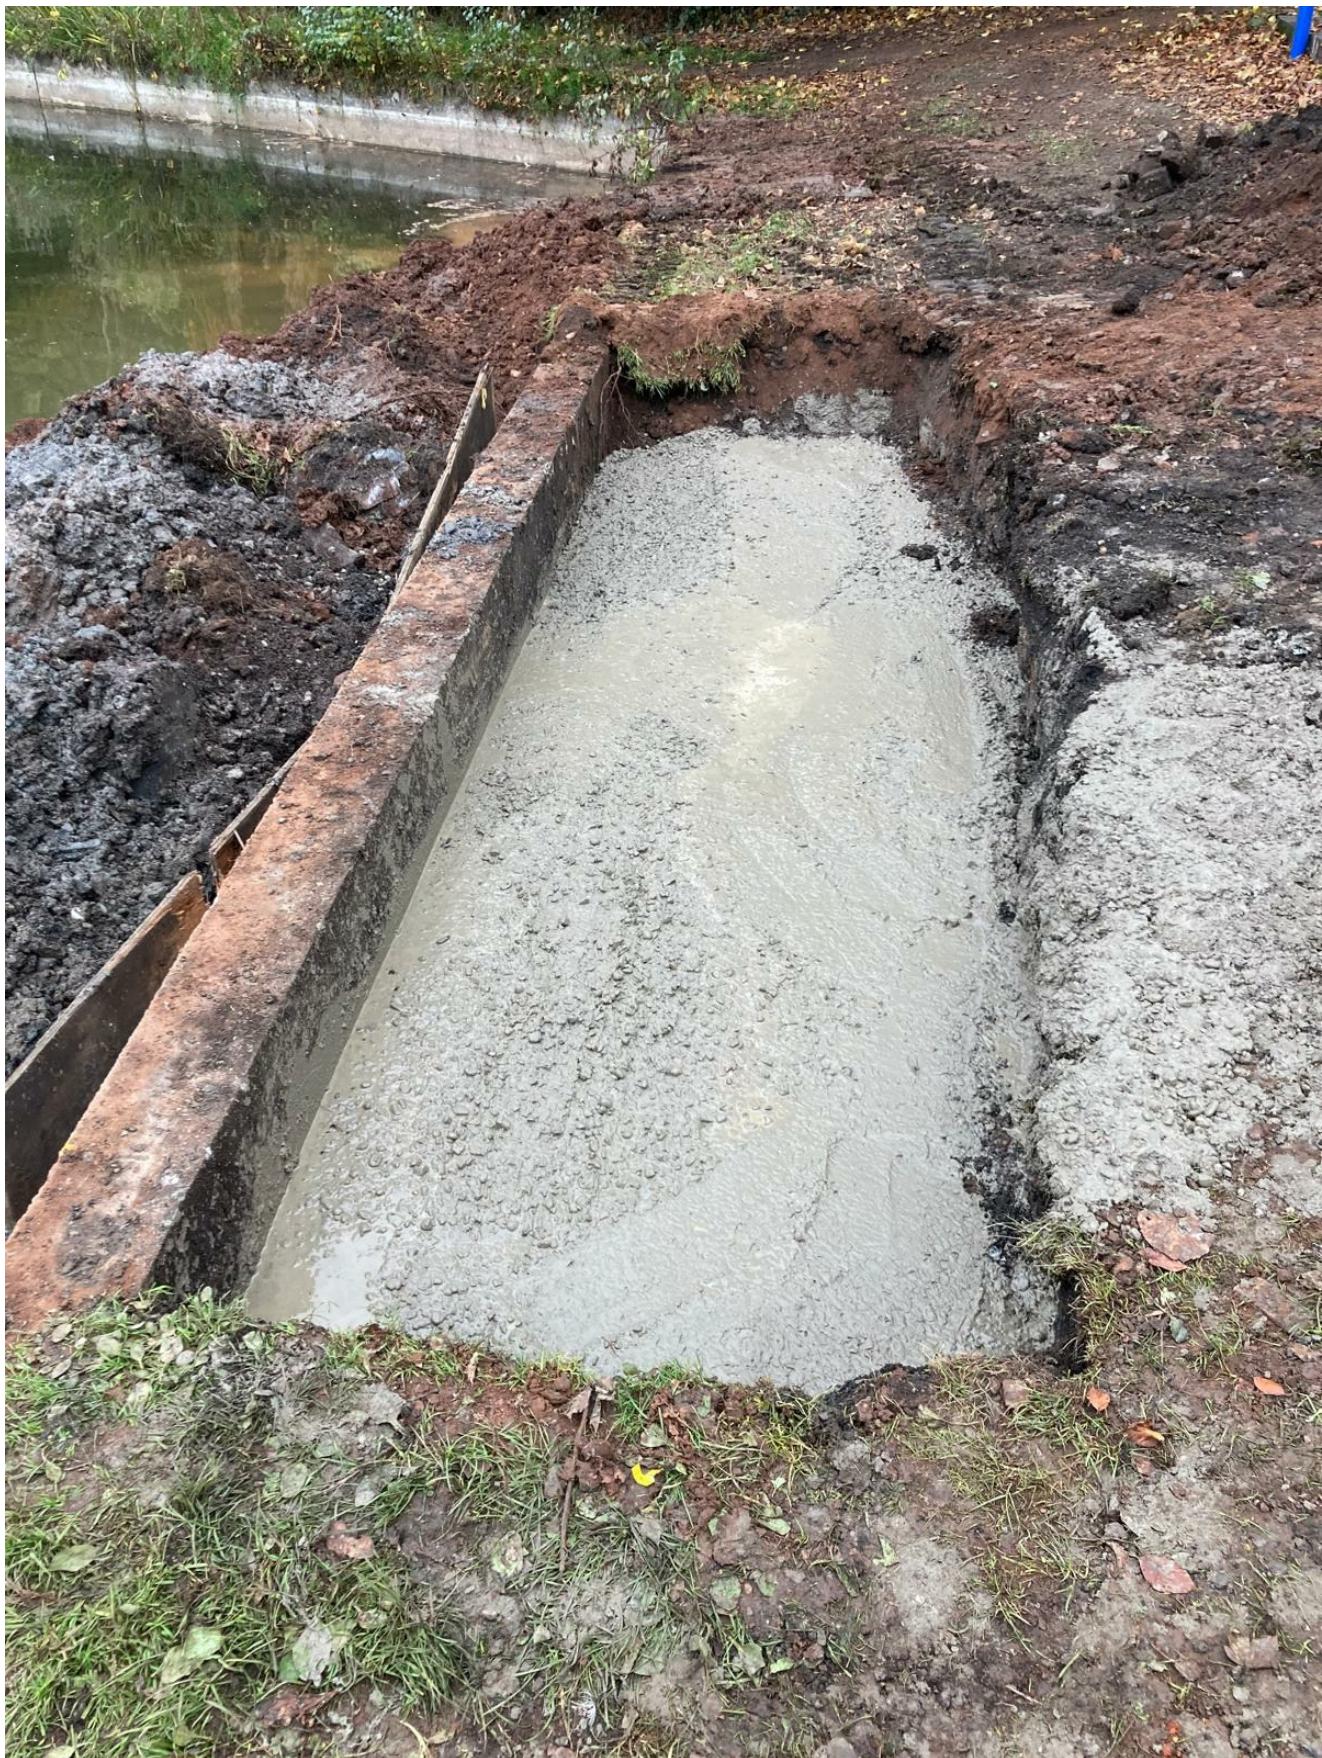
Photo showing concrete backfill of the wall foundation to seal the void

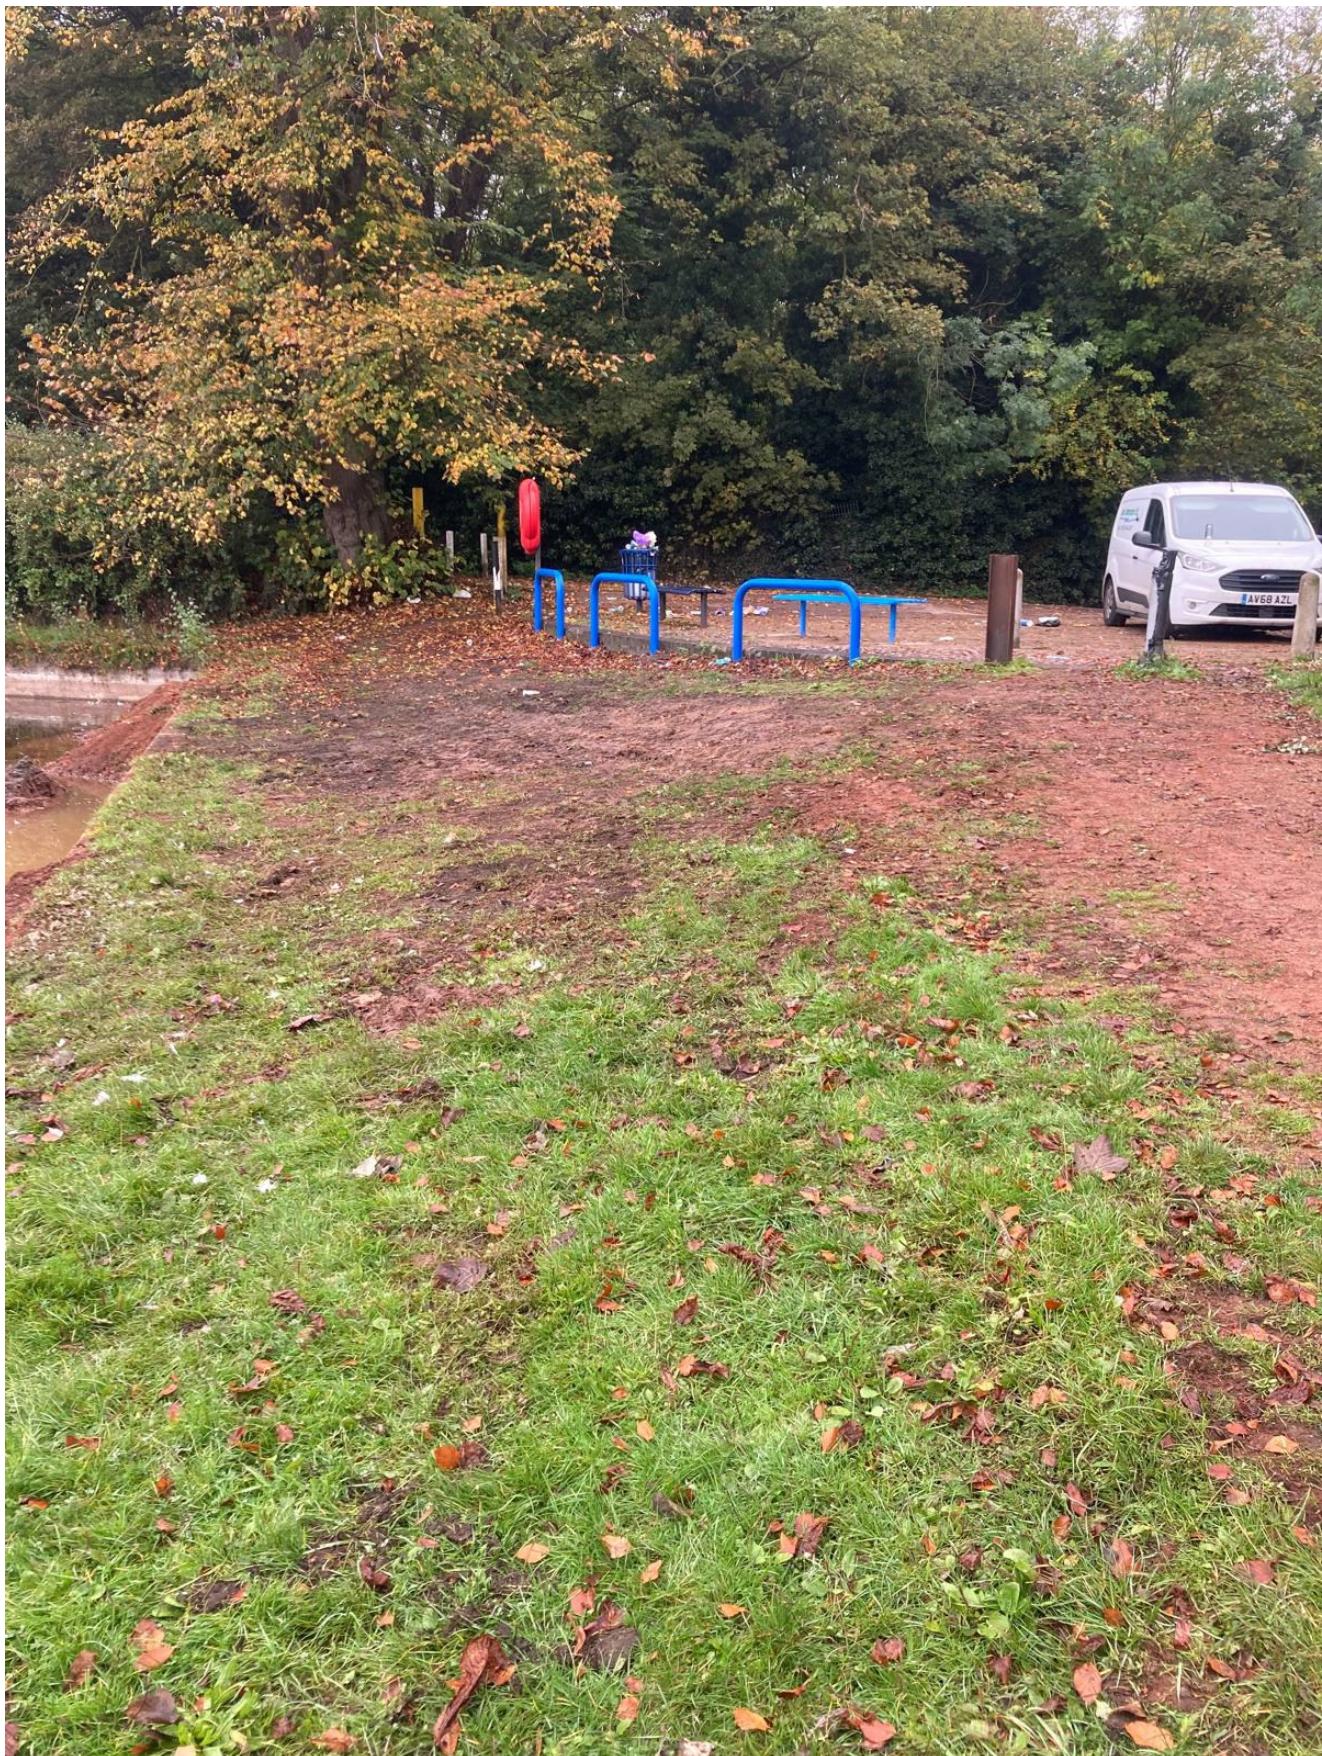
Photo showing dam embankment following repairs
