Case ID#

3356

Flooding from failure to manually close flood gates on flood storage reservoir

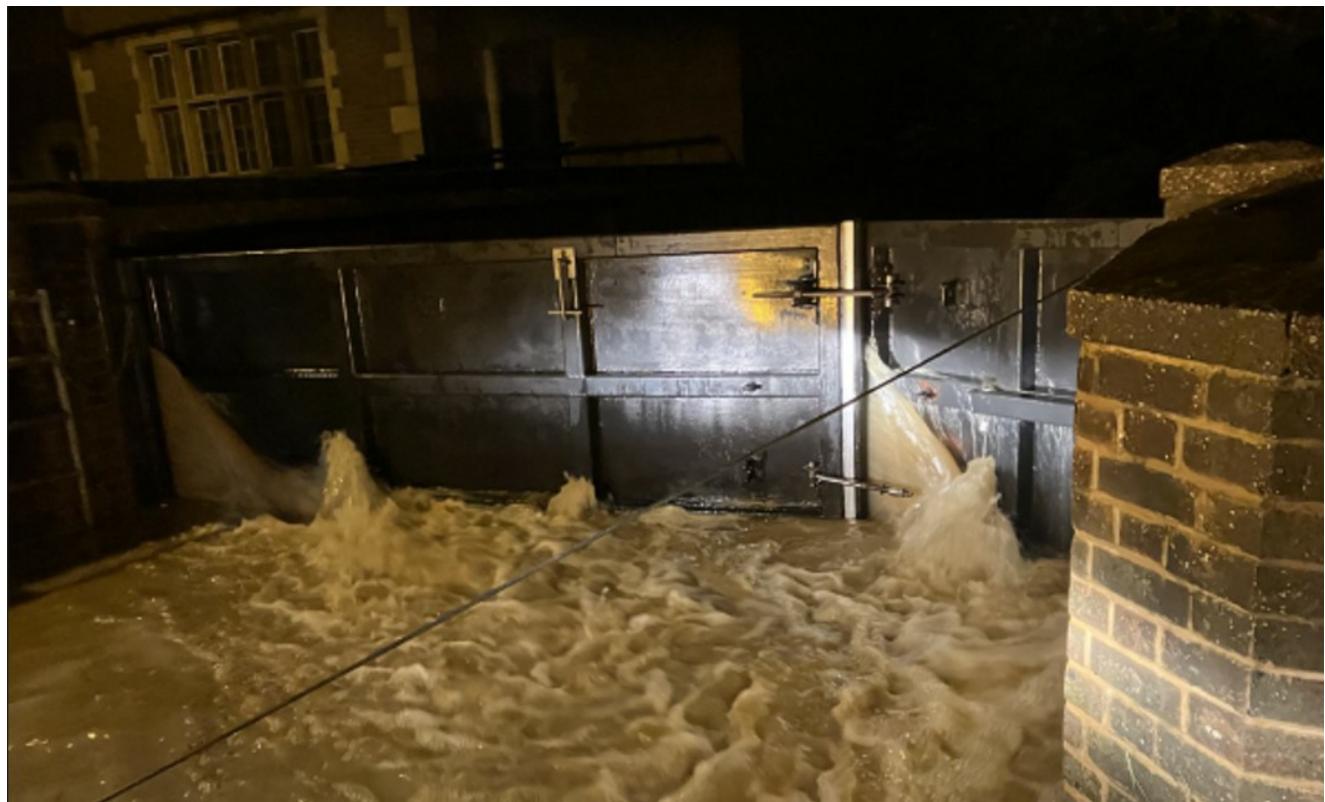
Upon arrival, operatives successfully closed and secured gates 1, 2, 3 and 4. However, gates 5 and 6 (double leaf flood gates) could not be fully closed and secured due to the excessive hydraulic pressure acting through the gate opening. The force of the water prevented these gates from reaching their normal sealing positions.

Flood waters coming through gate

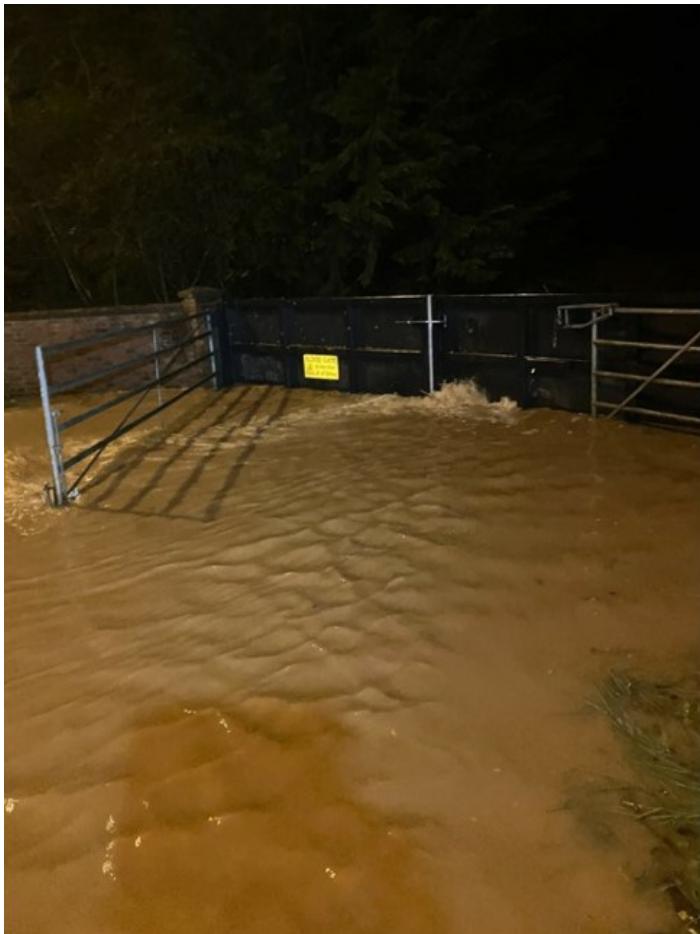
Floodwaters behind flood gates

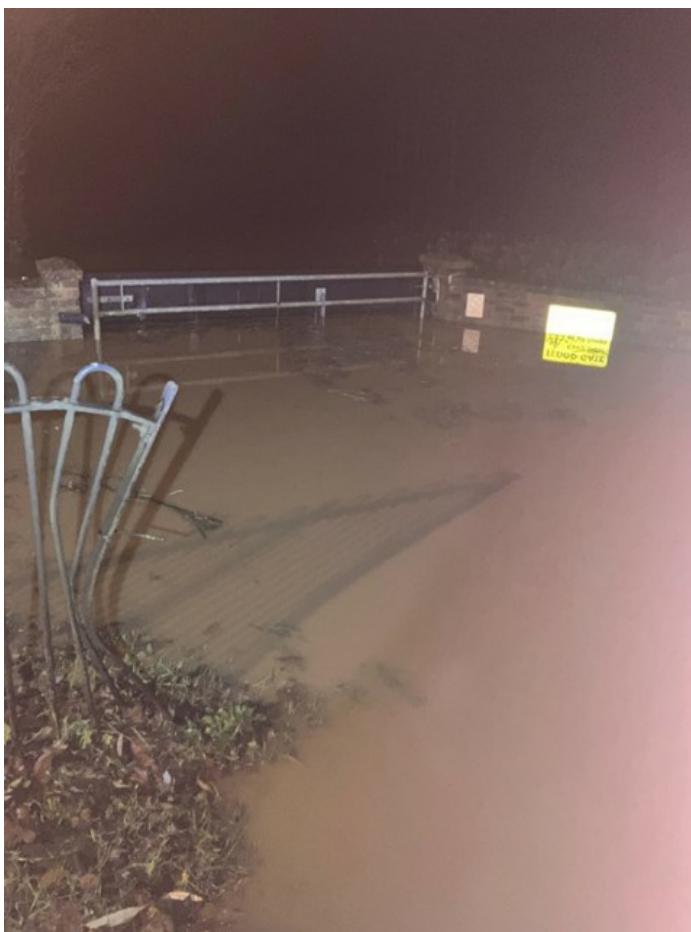
Flood waters behind flood gate

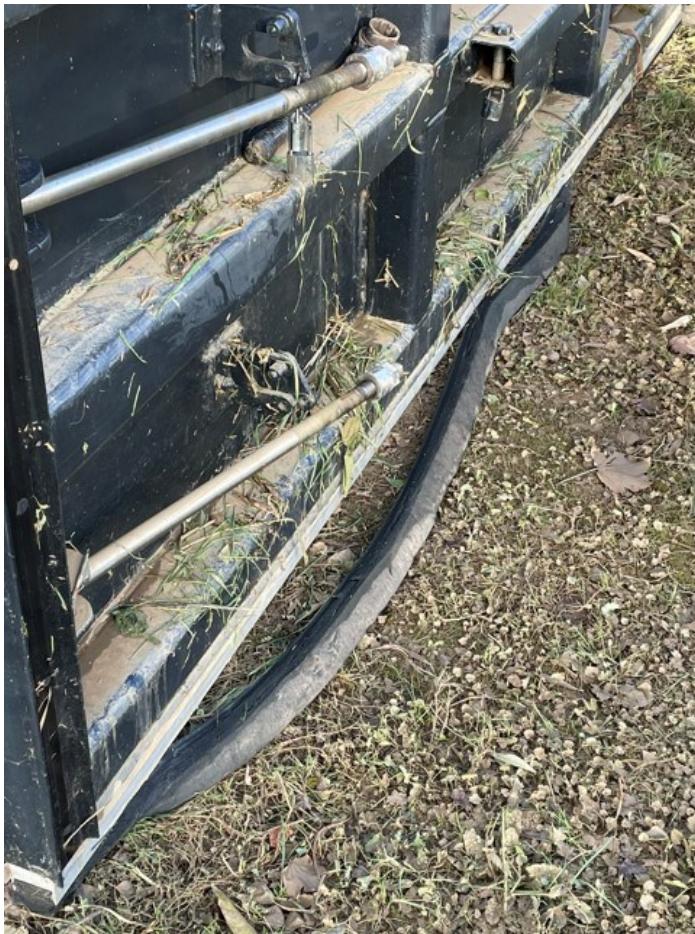
The incident occurred because the current telemetry trigger level did not provide sufficient time to complete the gate closure sequence before reservoir levels became too high. The rate of reservoir inflow exceeded the assumptions used when the gate closure trigger levels were originally established.

Damage to flood gates following incident

The following day, once water levels had subsided, the gates were inspected to assess any potential damage. Following the inspection, minor remedial works were identified on the gates which have subsequently been completed.

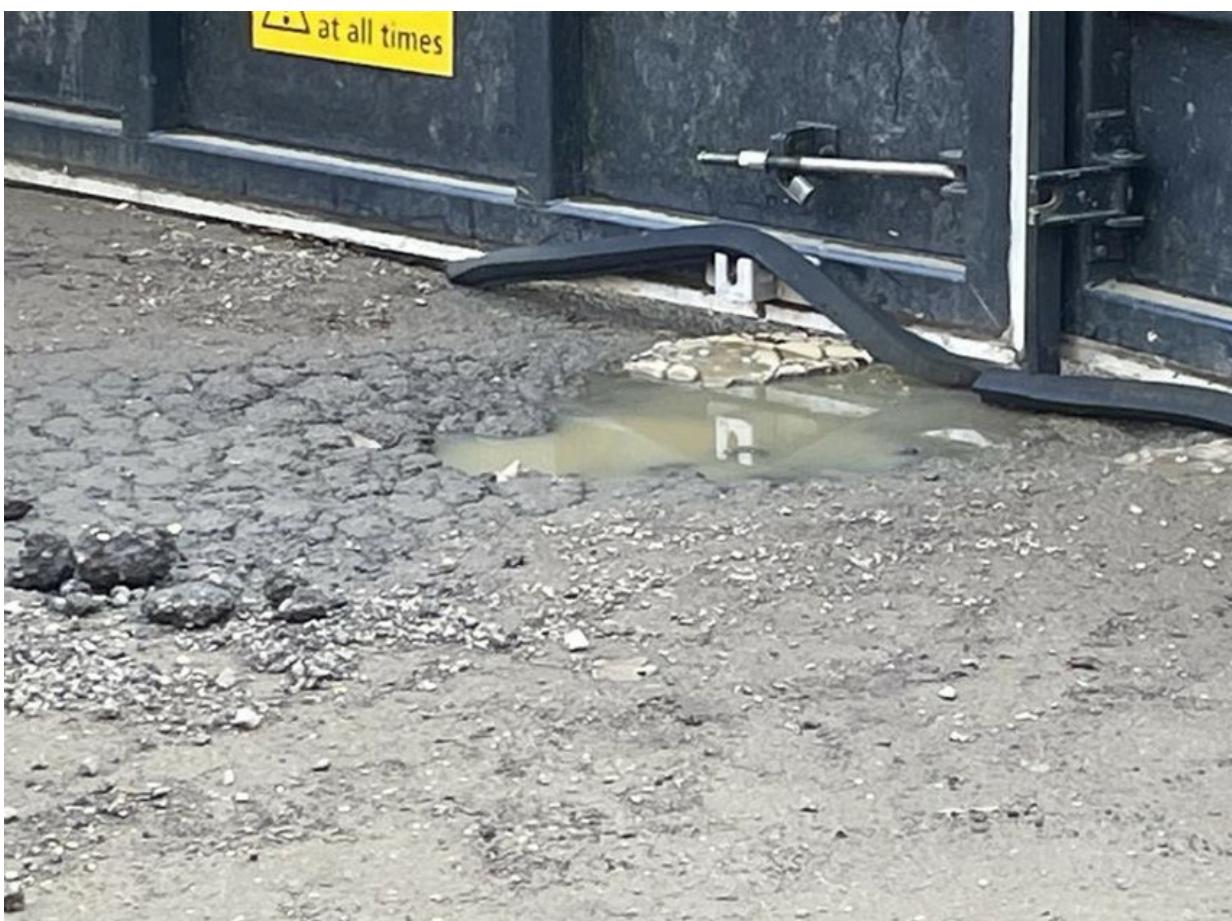
Damage to flood gates following incident

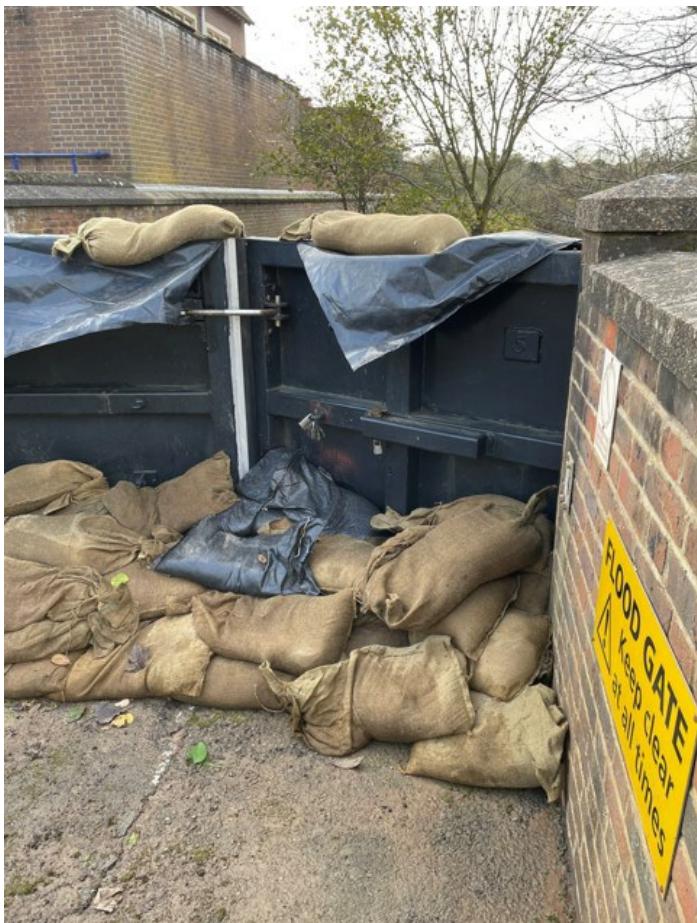
Members of the public assisted operatives in attempting to manually reposition gates 5 and 6 using a rope winch in order to achieve full closure. To further reduce water flow through these gates, plastic sheeting and sandbags were installed. The fire service provided additional support by pumping water away from nearby properties to help mitigate flooding impacts.

Sandbags and plastic sealing on flood gate
