3357

Breach of flood storage reservoir river embankments in exceedance event

England

Non-impounding

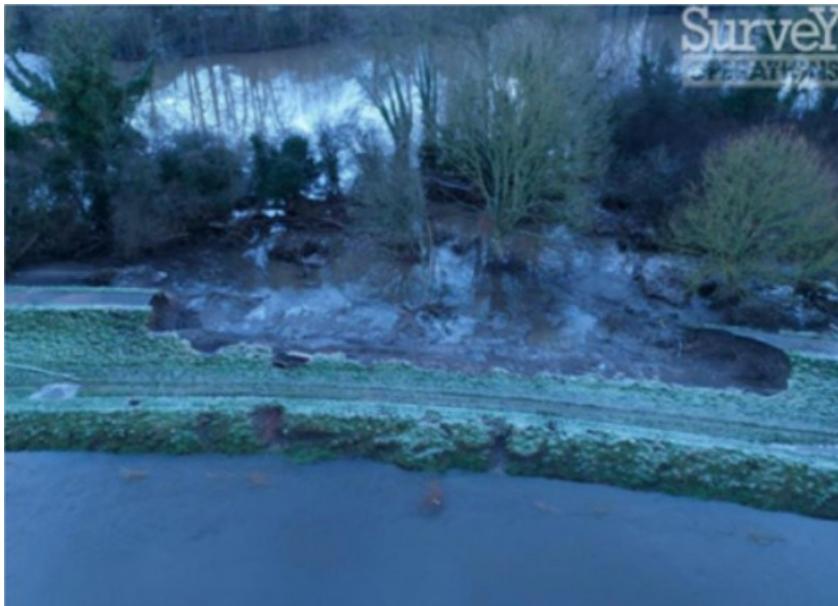
Due to the overtopping, erosion of the reservoir face of the embankment occurred leading to a breach of the embankment in multiple places. This caused impounding structures to be overtopped, however, these did not breach, and as such there was not an uncontrolled release of water from the reservoir. The exceedence event caused flooding to a nearby road and properties in various locations around the perimeter of the reservoir with residents being evacuated as required. Emergency works to install temporary embankment to protect breach location were completed in February using a helicopter to place tonne bags adjacent to the breach to reduce risk of unconstrained inflows through the breach, and create a suitable working area for permanent repair works.

Aerial photo of embankment breach

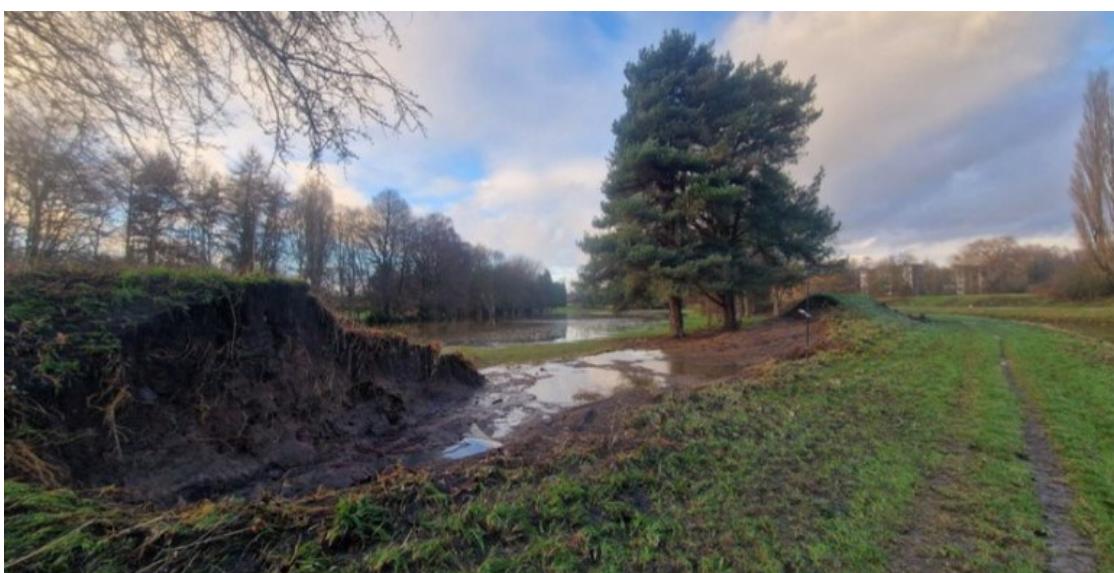
Photo of embankment breach

Flood event exceeded design standards of embankments adjacent to the river

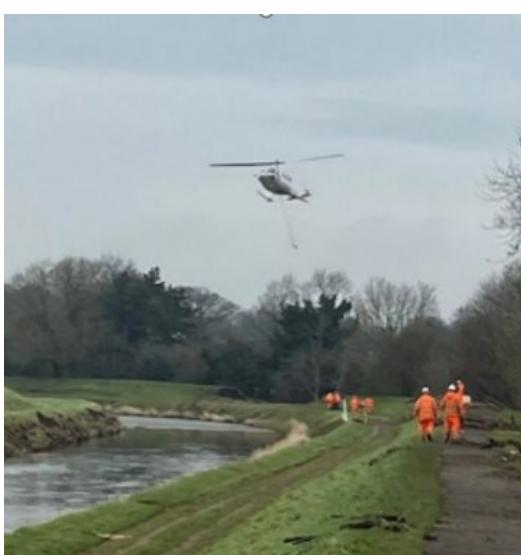
Photo of emergency repairs - helicopter dropping tonne bags

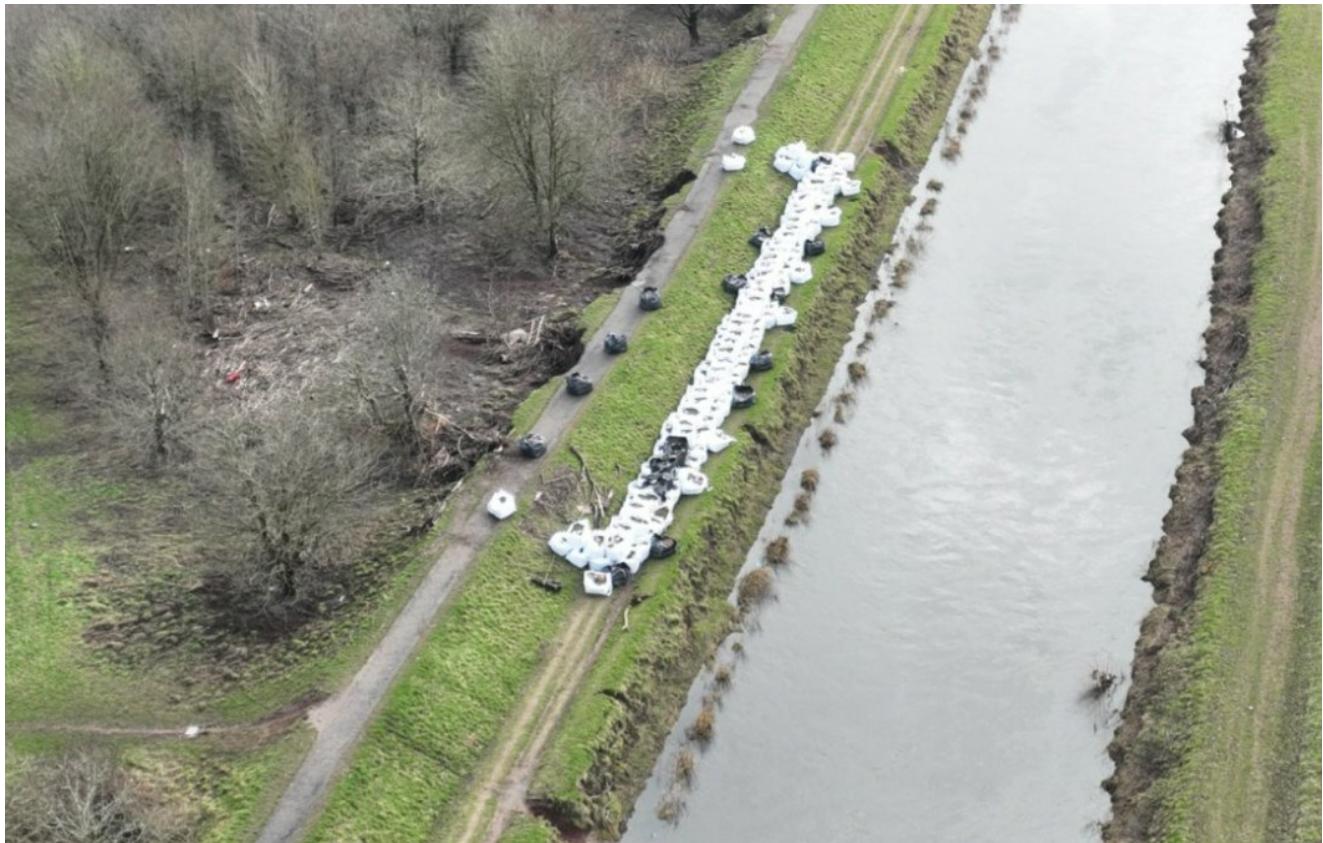
Aerial photo of temporary embankment repair showing line of tonne bags shoring up embankment

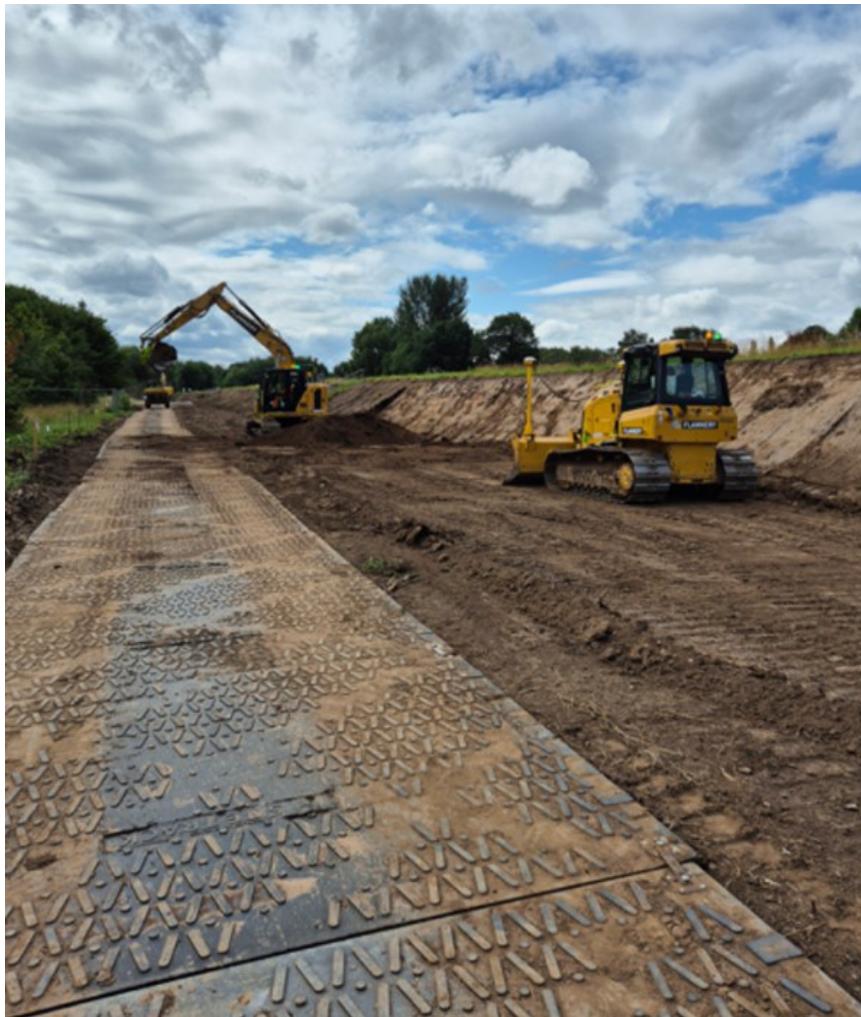
Photo showing installation of access route for Aerial photo of temporary embankment repair showing line of tonne bags shoring up embankment permanent repairs

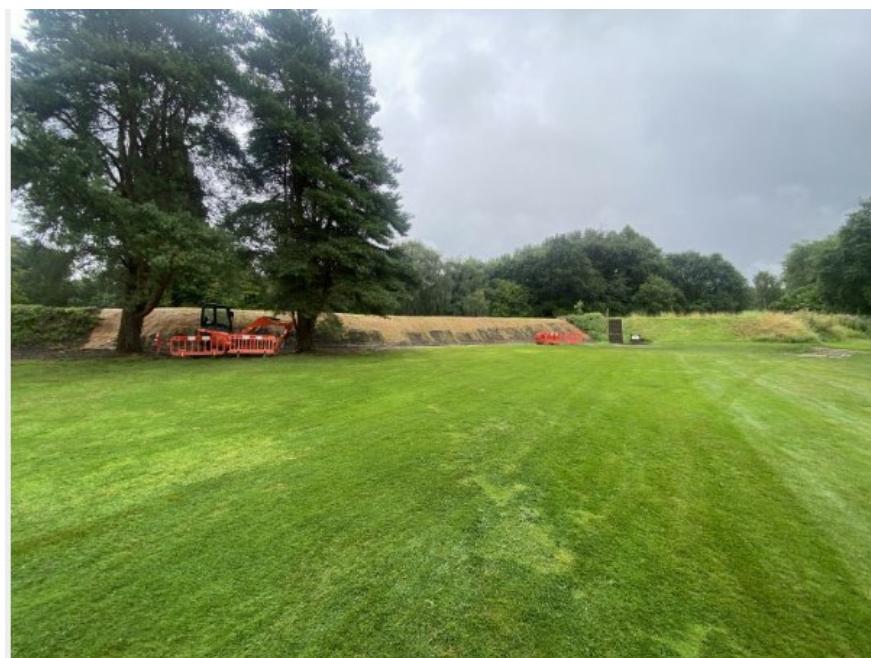
Photo showing completed repairs

Permanent repairs to reinstate the embankment have now been completed. This involved works to seal the 40m breach and repair a total of 400m of embankment. The embankment has been reinstated with a 1 in 4 reservoir face, making it resilient to overtopping (previous embankment had ~ 1 in 1.5-2 reservoir face). Trees previously located at the toe of the embankment have been removed to ensure an appropriate clear overtopping flow route is available.

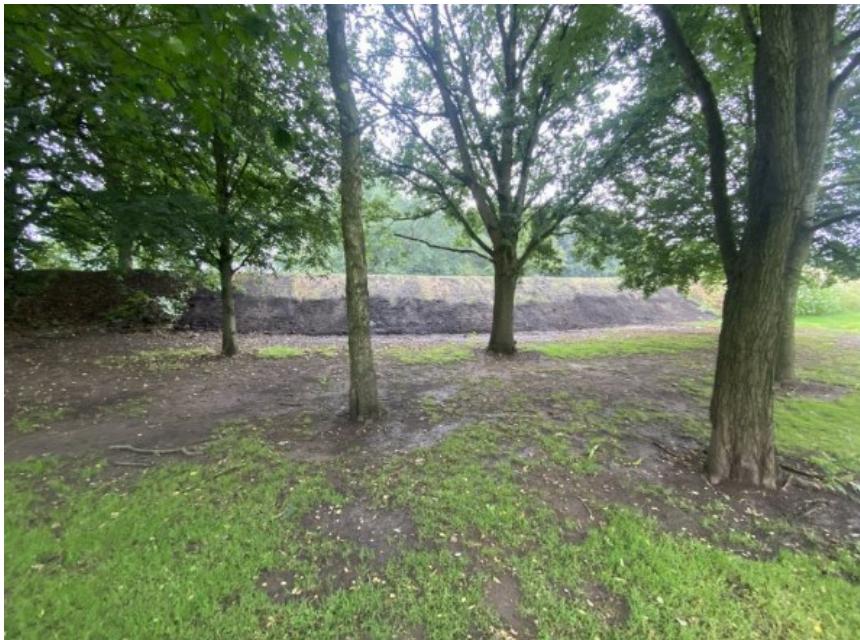
Photo showing completed repairs
