3358

Backflow Incident at Flood Alleviation Scheme due to outfall flap obstruction. (Flood defence designed to keep water out as opposed to storing water)

Wales

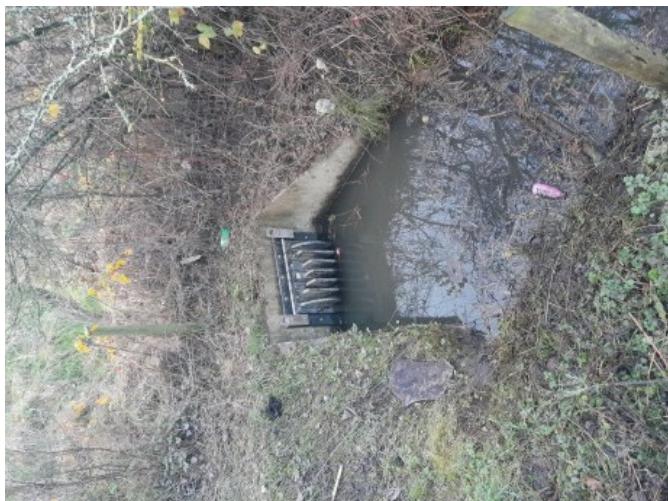
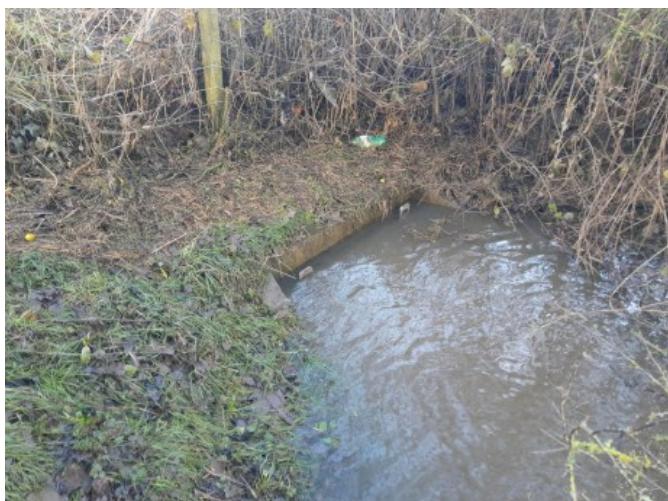
Backflow through surface water outfall observed during flood risk incident response & monitoring of assets. This was causing increased flooding on the road behind the impounding structure and could have resulted in flooding to properties if actions not taken.

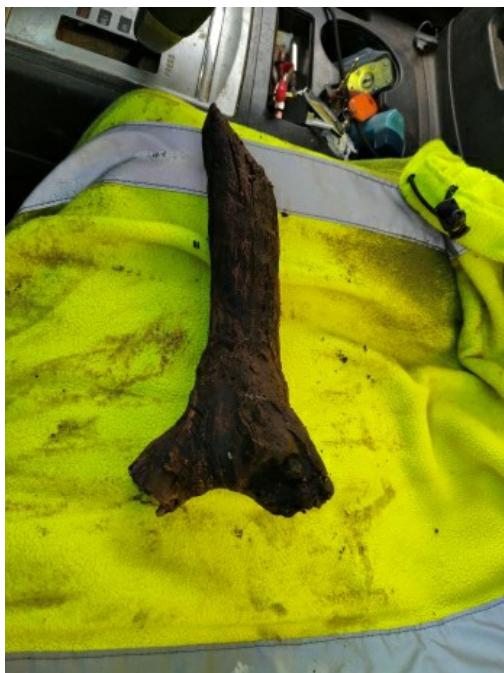
Debris obstruction in the culvert/outfall flap caused the flap to remain slightly open, allowing backflow through the structure into the area behind the defence.

Post-incident inspection after flood recession found the flap in good condition; timber debris was recovered and identified as the likely cause of jamming. Photographs were taken to document findings.

Investigate installation of an upstream weed screen to prevent debris ingress.

Consider an upstream penstock at/near the manhole to isolate backflow and improve resilience.
