3361

Spillway defect / rutting identified following heavy rainfall

Earth fill embankment

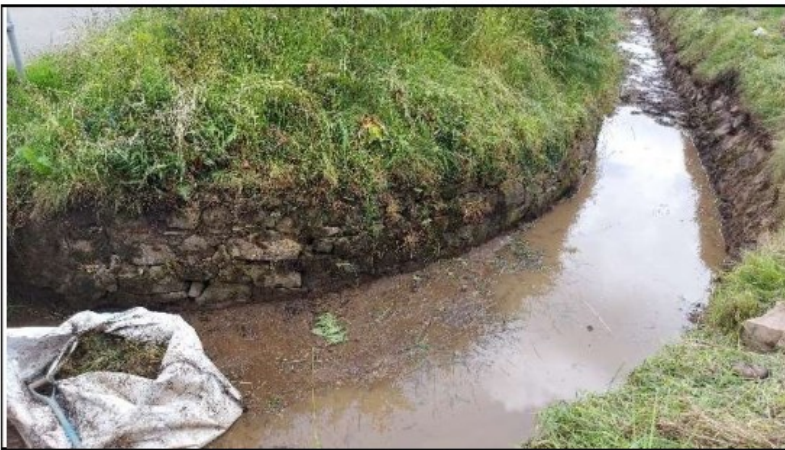
Photo 1: Spillway bend just downstream of bridge. Note this is low spot and is holding water.

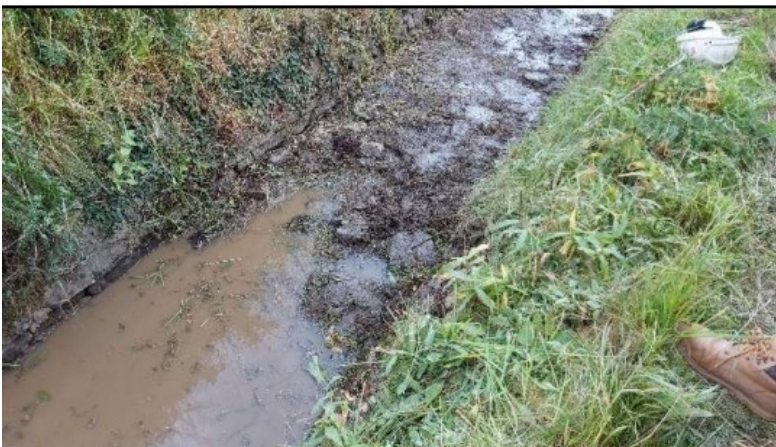
Photo 2: Earth that has built up in the spillway channel prior to cleaning.

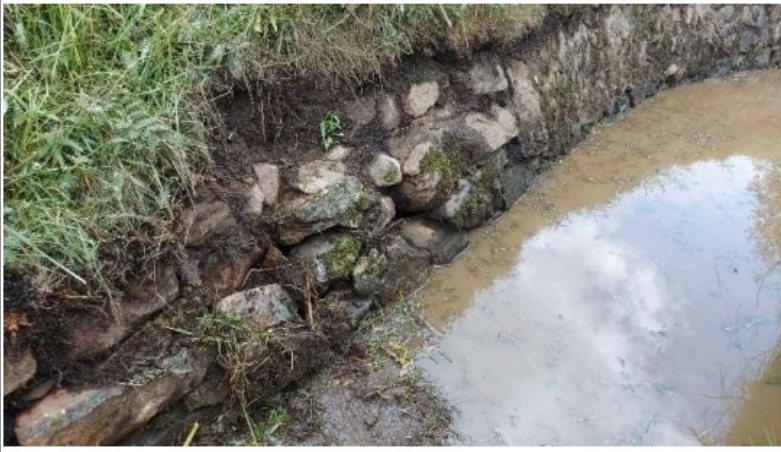
Photo 4: Poor condition on masonry on right hand side of spillway channel.

Very intense rainfall combined with missing/deteriorated blockwork, which allowed water to leave the spillway and erode soil behind the walls. Earlier identification limited escalation, but post-storm inspections could further mitigate future incidents.

Mitigating: Early detection during the S12 inspection. Immediate infilling of voids with stone material.
