3364

Subsurface defect arising from buried redundant construction materials

Wales

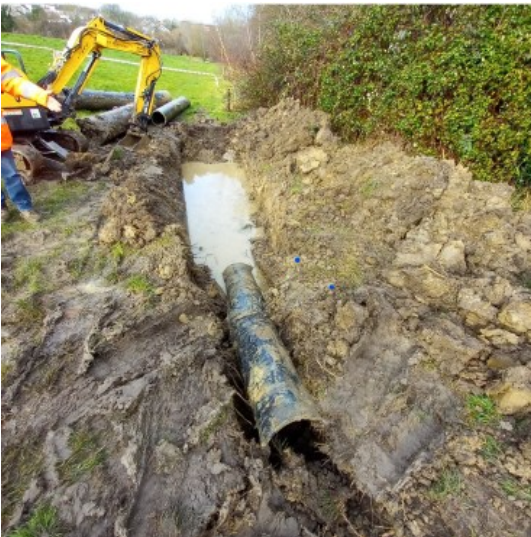
A ground defect was identified adjacent to a reservoir spillway following visual inspection, indicating potential subsurface instability. Investigation confirmed the presence of buried redundant construction materials dating from earlier works, which had enabled water retention and localised ground saturation. While no immediate loss of reservoir safety occurred, the issue represented a credible risk that required investigation and remedial action.

The root cause was a construction shortcoming during the 2016 reservoir works, where redundant temporary pipes were left buried within the embankment and not identified or removed.
