3368

Near miss from unpermitted works at toe of reservoir by third party

Earth fill embankment

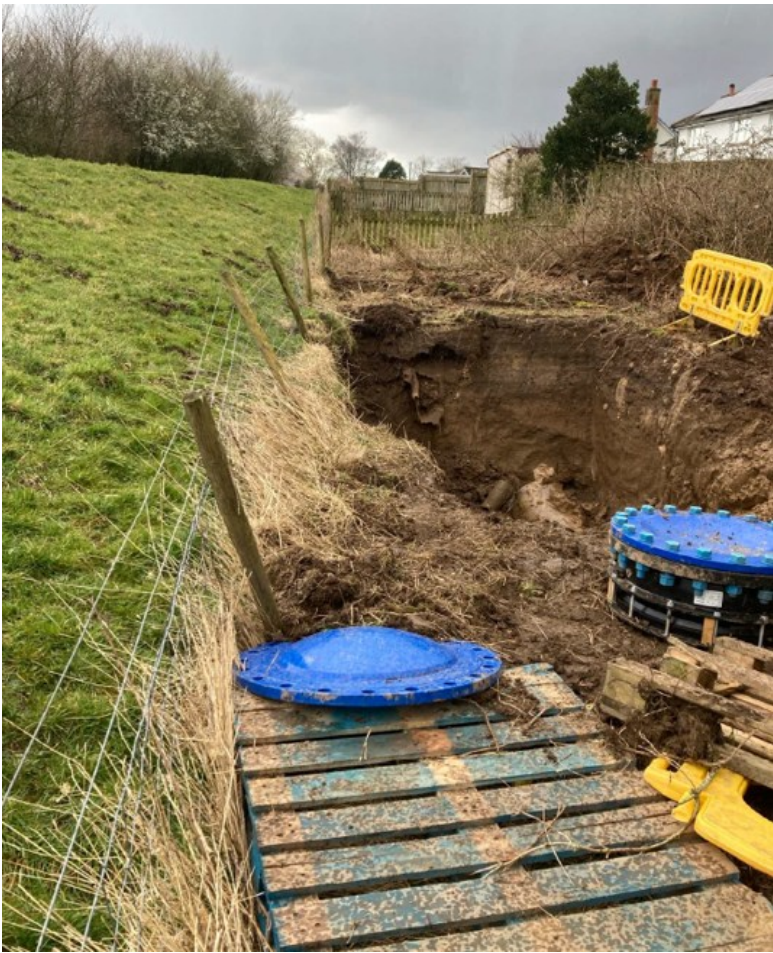
On Wednesday 12th March 2025, contractors acting on behalf of a utility company, began work to excavate and cap a derelict water pipeline at the toe of this flood storage reservoir's retaining embankments. The works involved digging a trench approximately 4m deep and 2m wide. The reservoir undertaker's staff found the excavation during routine checks on the 12th March 2025. At the time there were no contractor operatives on site. The excavation had no shoring up or support. The following day, the site was visited by undertaker staff and they spoke to the contractors doing the works. By this point, the trench had been back filled. The operatives said that they were about to re-excavate the water pipeline as they had only capped one side of the pipeline the previous day; leaving the other side open. During conversation, it was apparent there was no urgency for the works. It was determined the Environment Agency had not been notified of the works and no Flood Risk Activity Permit (FRAP) was sought. The operatives were asked to stop work and leave site. The contractors provided details of their contact at the utility company who had issued the work order. Following this, the reservoir Supervising Engineer was notified of the unpermitted works. The supervising engineer has visited site and did not find any noticeable movement in the embankment so it has been deemed a near miss. Enforcement is now being undertaken against the utility company for the unpermitted works and the undertaker is working with the Environment Agency, seeking to issue a remediation notice so that the other side of the pipeline can be capped. The supervising engineer has provided specifications on how this work is to be undertaken.

The open excavation on the landward toe of the embankment had the potential to cause sliding of the reservoir earth embankment during loading when the reservoir was in operation. This scenario did not occur as the reservoir was not needed to be operated before the works were reinstated.

Unpermitted works identified adjacent to dam bank

The root cause of the incident was a failure of planning, risk assessment and regulatory compliance from the contractor working on behalf of a utility company. This allowed contractors to undertake excavation works adjacent to a statutory reservoir embankment without obtaining the necessary permits, consulting a Qualified Civil Engineer or without consideration for assessing the potential impact on embankment stability.

All work was paused immediately. The operator contacted the relevant Environment Agency enforcement team who undertook enforcement action to ensure remedial works were undertaken. These works commenced within 2-3days. The Supervising Engineer attended the following week to assess and was satisfied that no damage had been caused to the reservoir embankment.

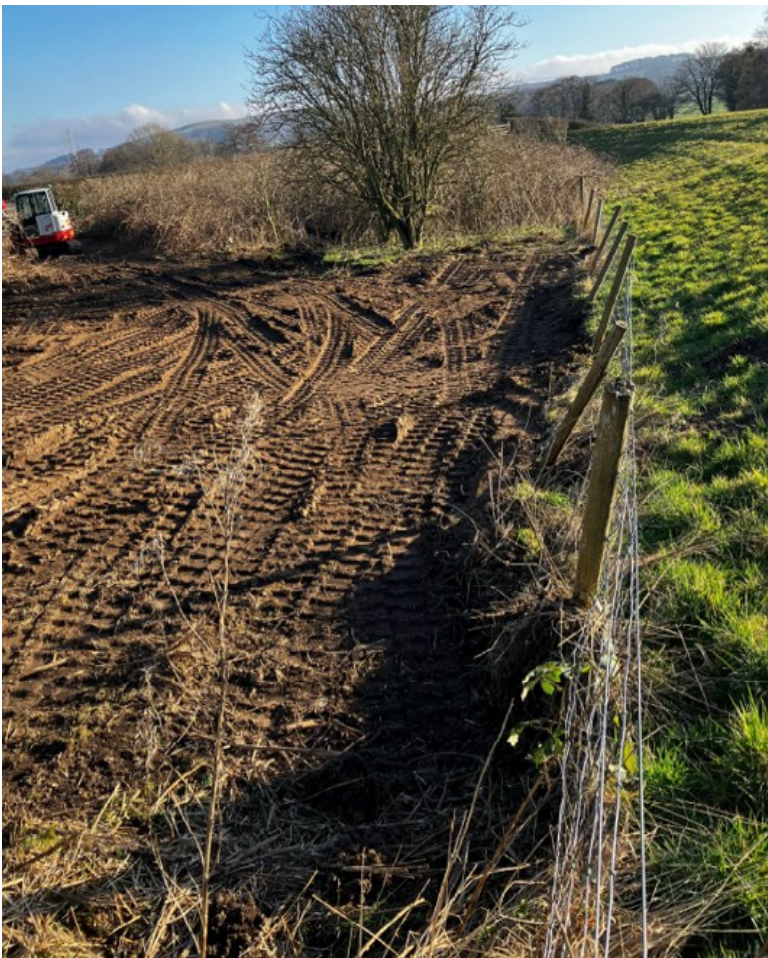
Reinstated works
