3342

Scour damage to spillway channel following storms

Wales

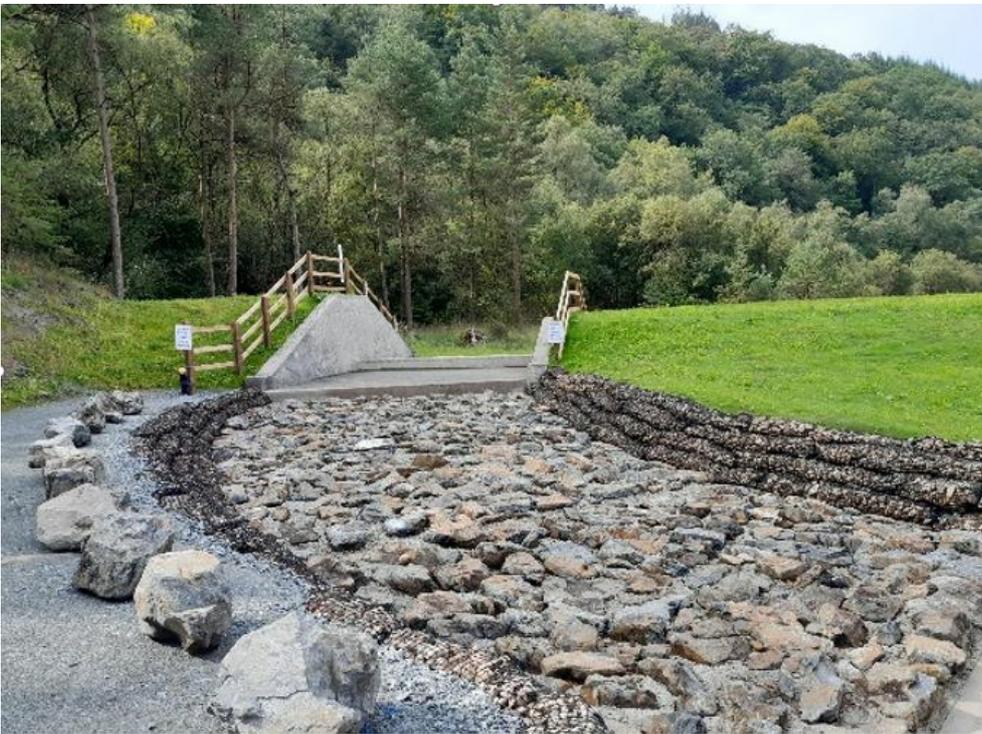
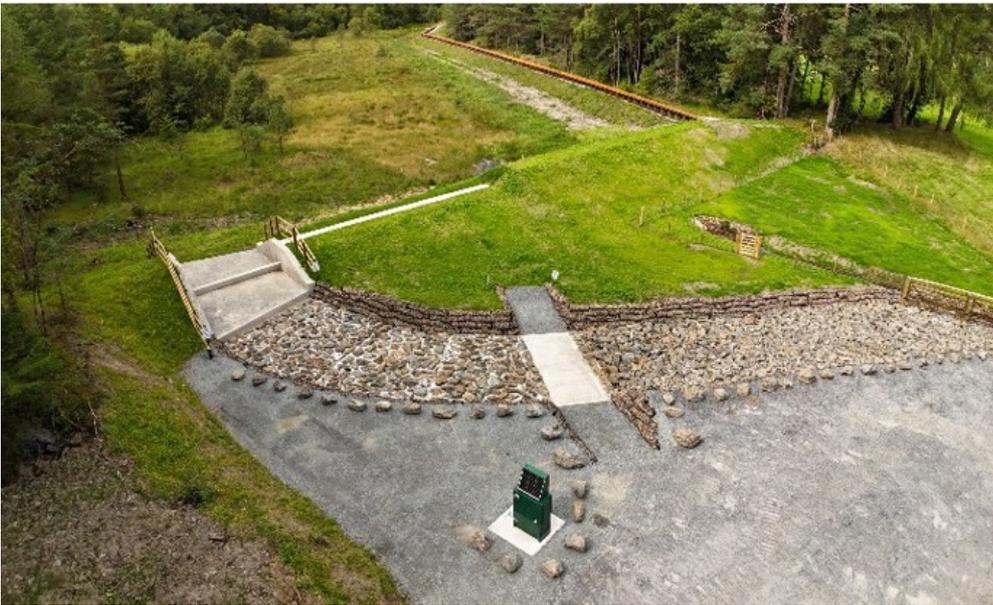
Supporting Photos

Following routine surveillance, the Supervising Engineer was alerted of scour dam to the old narrow masonry spillway channel following storms in early January 2025 and resulting in reservoir impoundments. The hole in the spillway started at around 4pm from the upstream entrance of the spillway, which was approximately 4.5m in length / 1.5m in width and around 1m deep. SE attended site and initiated telephone discussions with the QCE. Remedial works were agreed on later that day, including MIOS improvement works to replace the existing spillway.

Old narrow and inadequate masonry spillway channel deteriorating following storm / flood events, leading to scour damage.

Continued routine and reactive surveillance of the dam is essential, especially at times of flood and impoundment. The system the undertaker worked well, with the incident being immediately escalated to the SE, who in turn immediately made contact with ARPE / QCE. On the same day as the initial call from the undertaker from site, a meeting had been held between the SE, undertaker and QCE, and appointed contactor, to agree the required remedial works and timescale. By the 21st January 2025, the temporary repairs to the spillway were complete
