28 October 2025

3345

Partial failure of outlet pipe leading to internal erosion in flood storage reservoir, exacerbated by a blocked debris screen

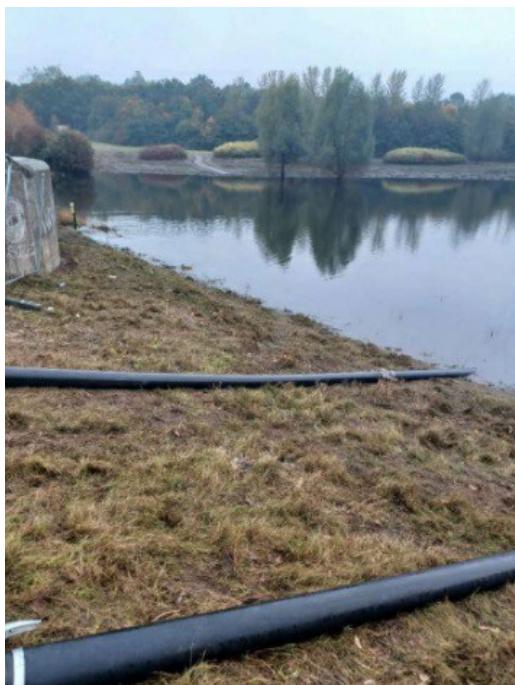
Supporting Photos

A previously unknown failure of the outlet pipe caused internal erosion, where fines were washed down causing a sinkhole on the upstream face of the dam. A blocked debris screen from grass cuttings on the outlet meant the flood storage reservoir was held at a higher level than normal. This triggered investigation of the condition of the outlet pipe and identification of the partial failure of the pipe.
