3361

Spillway defect / rutting identified following heavy rainfall

Earth fill embankment

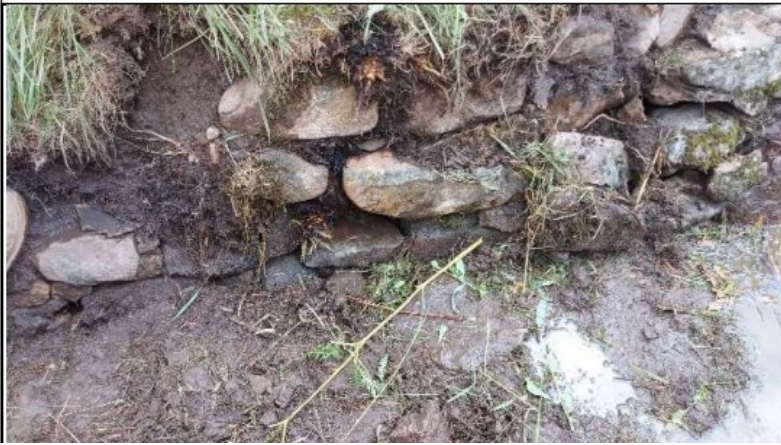
Rutting of the grassed area along the spillway footpath. Voids formed behind the spillway bank walls. Missing blockwork identified on the spillway walls during the S12 inspection.

Photo 4: Poor condition on masonry on right hand side of spillway channel.

Very intense rainfall combined with missing/deteriorated blockwork, which allowed water to leave the spillway and erode soil behind the walls. Earlier identification limited escalation, but post-storm inspections could further mitigate future incidents.

Greater emphasis required on scheduling inspections after periods of intense rainfall. Maintenance shortcomings identified (missing blockwork). Surveillance shortcomings identified (issue found during routine inspection rather than targeted post-storm checks).
